69 and 71 Micklegate City of York

Historic Building Recording and Heritage Assessment

AOC Project No: 51254

Date: September 2014

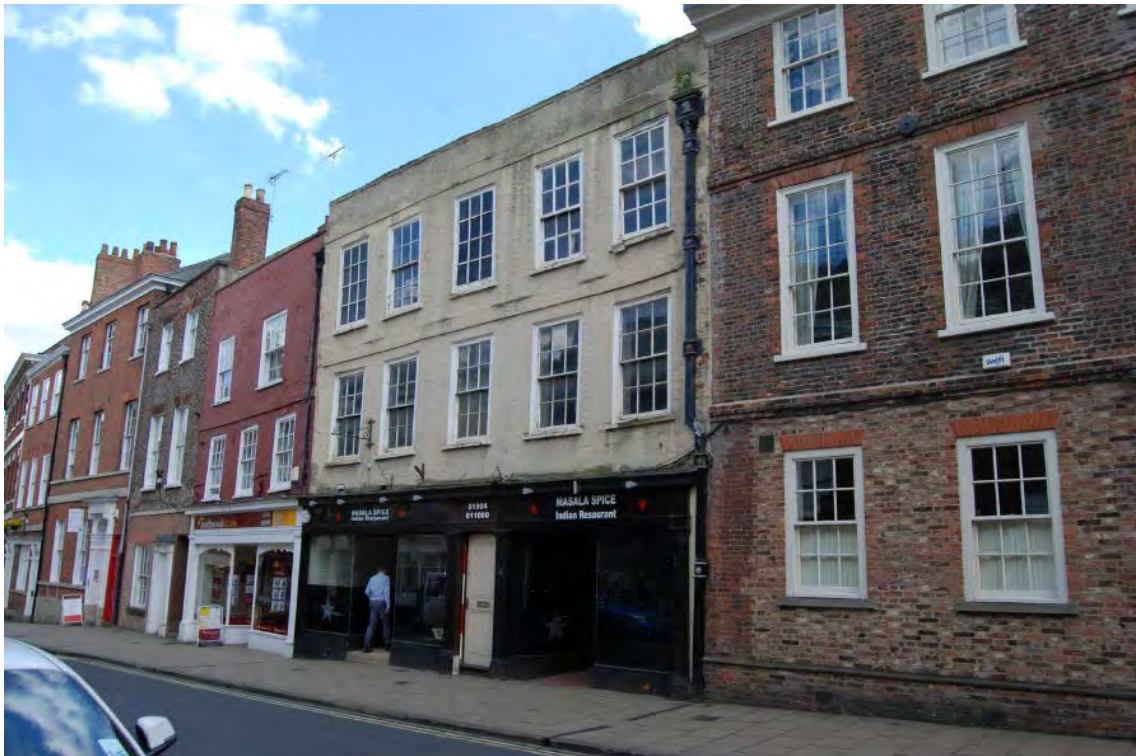
Plate 1. A view of the Micklegate elevation looking south-east

- 9.5 The modern shop frontages will be removed and replaced with hardwood-framed double-glazed shop fronts. The existing pilasters, cornice and capital details will be refurbished and replaced, to maintain the 19th century character of the shop frontage. The entrance doors to the shops will remain recessed and in the same location, and new stone flagged-steps constructed. It is considered that the refurbishment will enhance the historic character of the shop fronts through the retention of period detail, while replacing poor-quality modern additions.

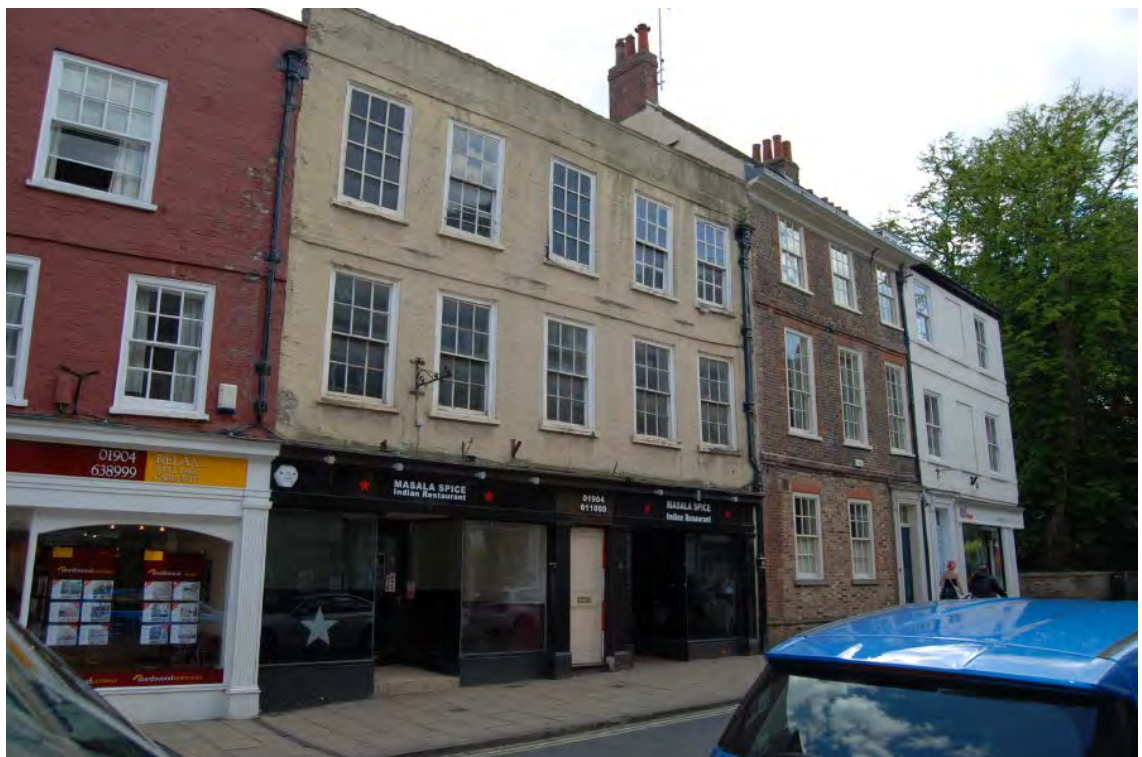
Plate 2. A view of the Micklegate elevation looking south

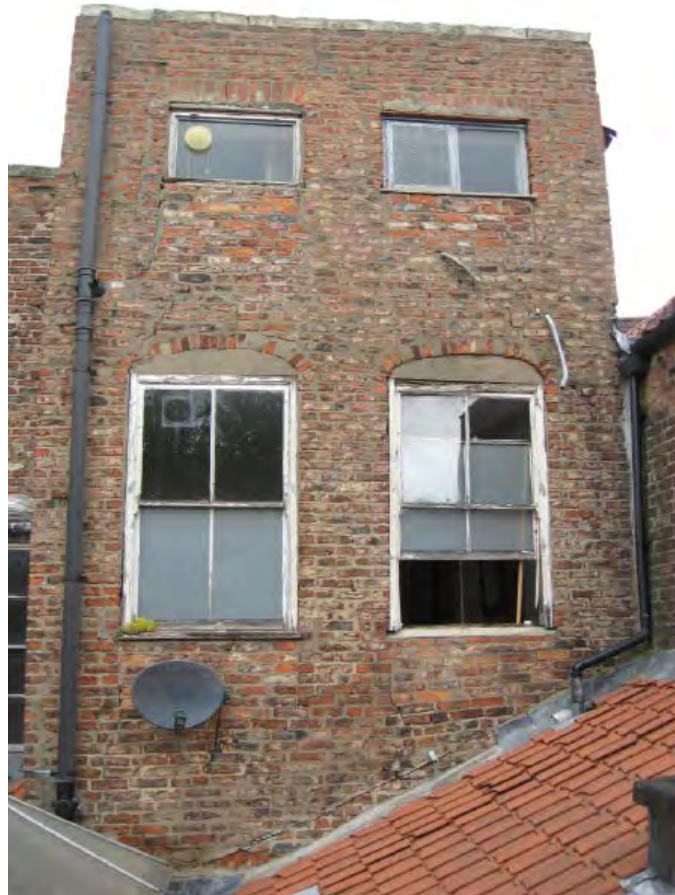
- 10.4 In the late 20th century the building fell into disrepair and poor maintenance of the exterior has led to significant water damage. The rear projecting elevation in particular is in very bad condition. Internal

Plate 3. The east side of the rear elevation

- 9.9 The north-eastern side of the elevation, forming the back of 69 Micklegate, is in very poor structural condition and will need to be fully rebuilt to reinstate the structural integrity of this part of the building. This will include the construction of new masonry walls, which will be faced with handmade clamp bricks in keeping with the character of the existing elevation, together with the replacement of hard wood box sash windows. At ground floor level a new sash window will be inserted, together with an exterior door providing access to Apartment 1.

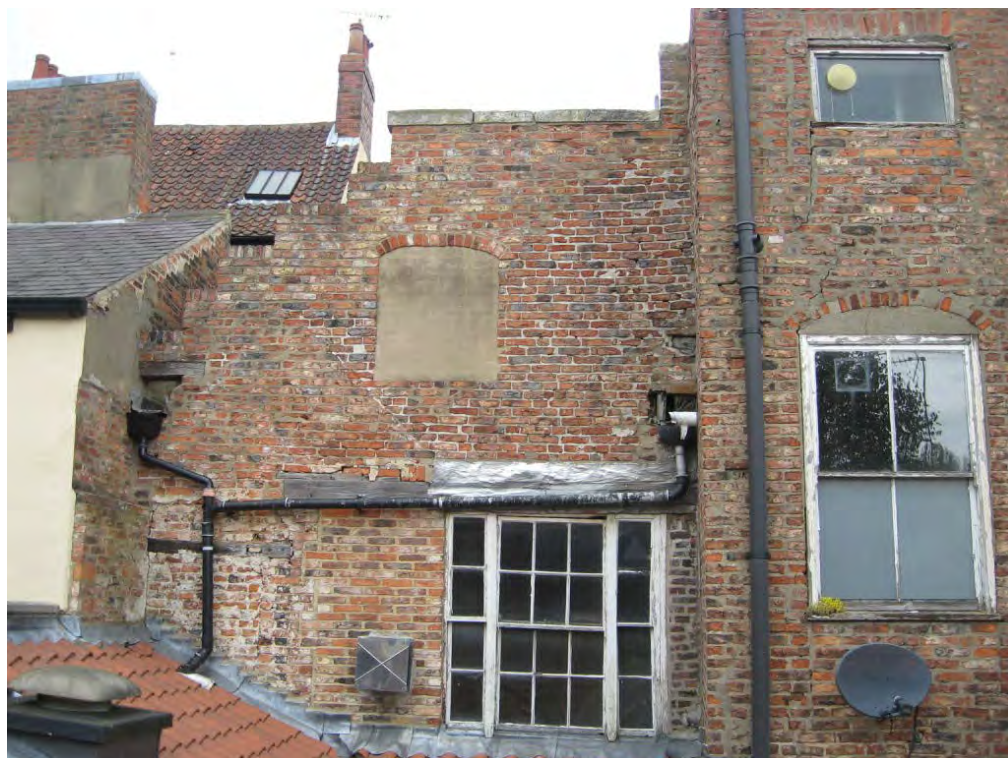
Plate 4. The west side of the rear elevation

- 9.7 The upper south-western side of the rear elevation, forming the back of 71 Micklegate, will be restored, including the replacement of decayed wooden lintels with steel and the replacement of coping stones with new York stone. The large sash window in this elevation will be replaced by a new hard wood frame, with the design and all the detailing of the new frame matching that of the existing window.
