# 69-71 MICKLEGATE

## Supporting Statement

Incorporating Design & Heritage Statement  
& Update on Flood Risk

Job Ref                    Y001-69-71 Micklegate  
Date:                      December 2016  
Revision:                 00

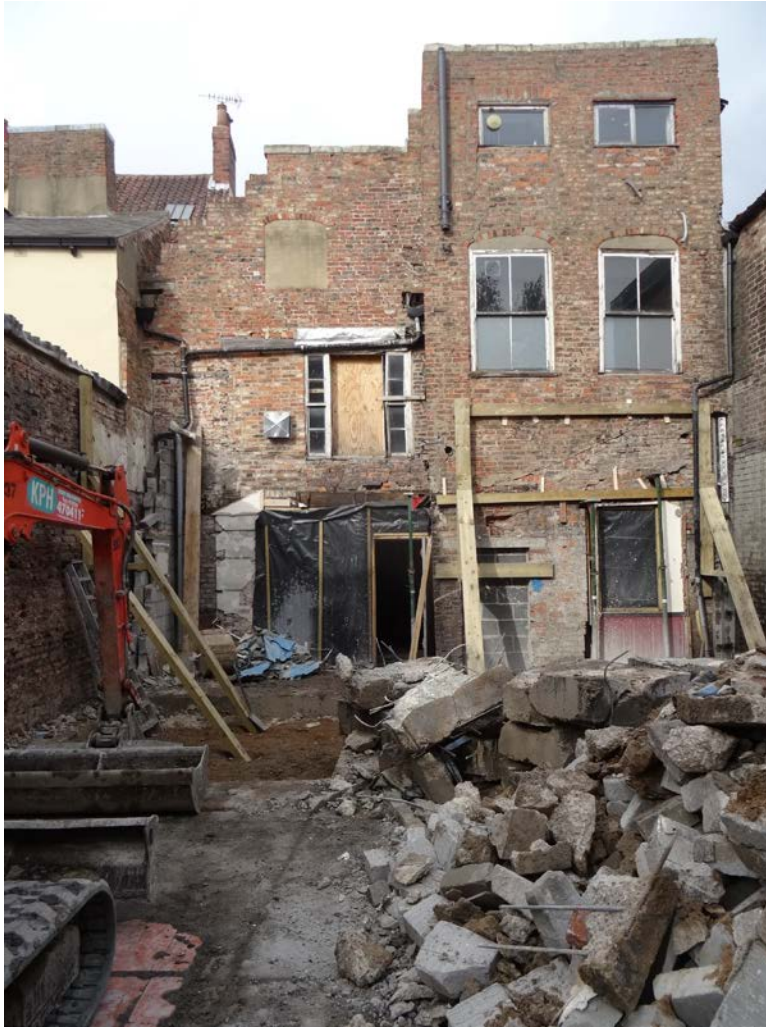
- Following the demolition of the rear elevation, we discovered original three centre arches to window openings at ground floor, it became clear there would be a practical

and aesthetic benefit to reinstate these openings rather than adjust the current modern openings as the current application.

Fig 1. – Rear elevation.

East side at ground floor amended to reinstate openings in original C18th position as depicted by three centre arches. We think the rear elevation is significantly improved by reinstating the openings and seek approval to amend the panelling layout in north elevation of room 1.5 to achieve this refer to drawing 650.

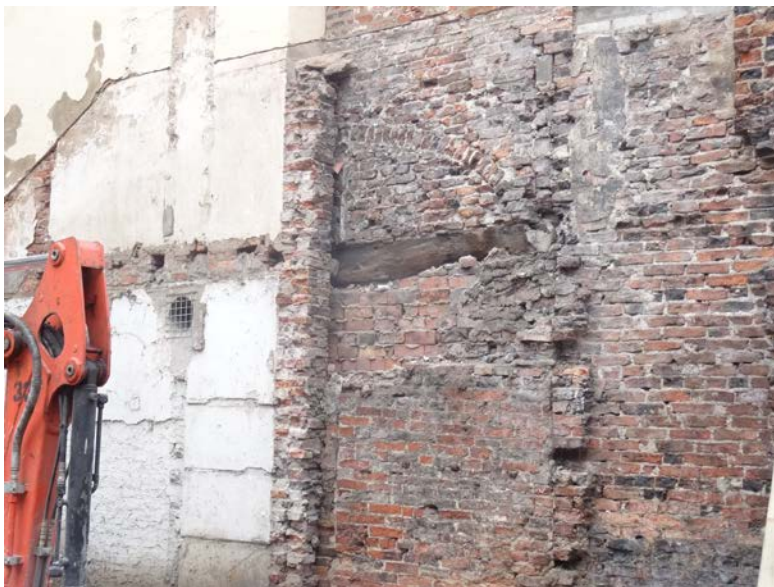
- When the rear extensions were demolished it was discovered the party walls were simply faced over with poor quality aerated lightweight blockwork; this would be unsuitable for an external environment and had to be removed, when removed it became clear the underling masonry of the boundary wall needed to be carefully repaired and new walls and piers are needed to help support weak areas. It was necessary to ensure integrity of the structures so we have started repair works in the form of new facing walls.

Fig 2. – Condition of newly exposed party walls – several areas of defective masonry.

Details new wall to face the boundary wall on the west side of the rear yard, this replaces the walls removed when the rear extension was demolished. The repair works and new walls are urgent and are currently underway to ensure the existing walls are adequately supported,

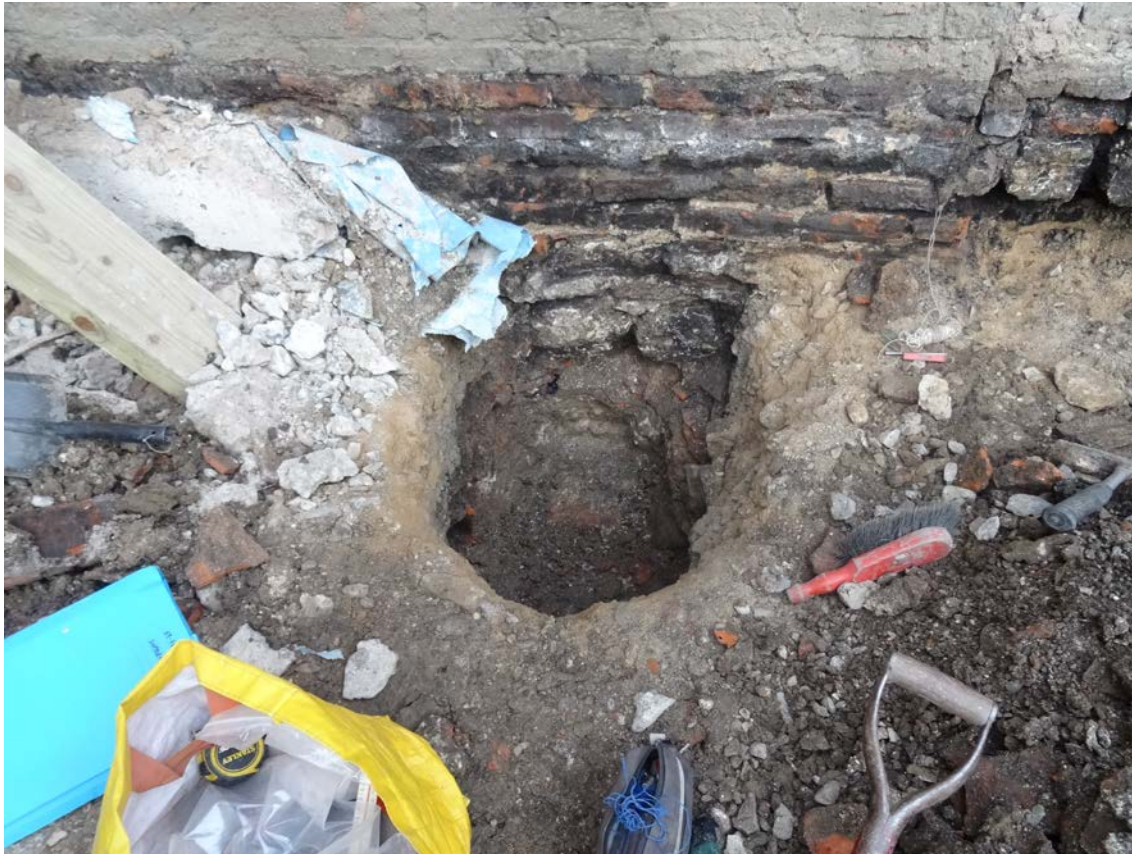
- Medieval walls have been discovered under the party walls to the adjoining building at 67 Micklegate, these may have been built using stones from the Roman structures that formerly stood on the site. The stone walls thicken out below ground which affects how the new facings to the walls are constructed.

Fig 3. – Discovery of medieval walls below party walls.

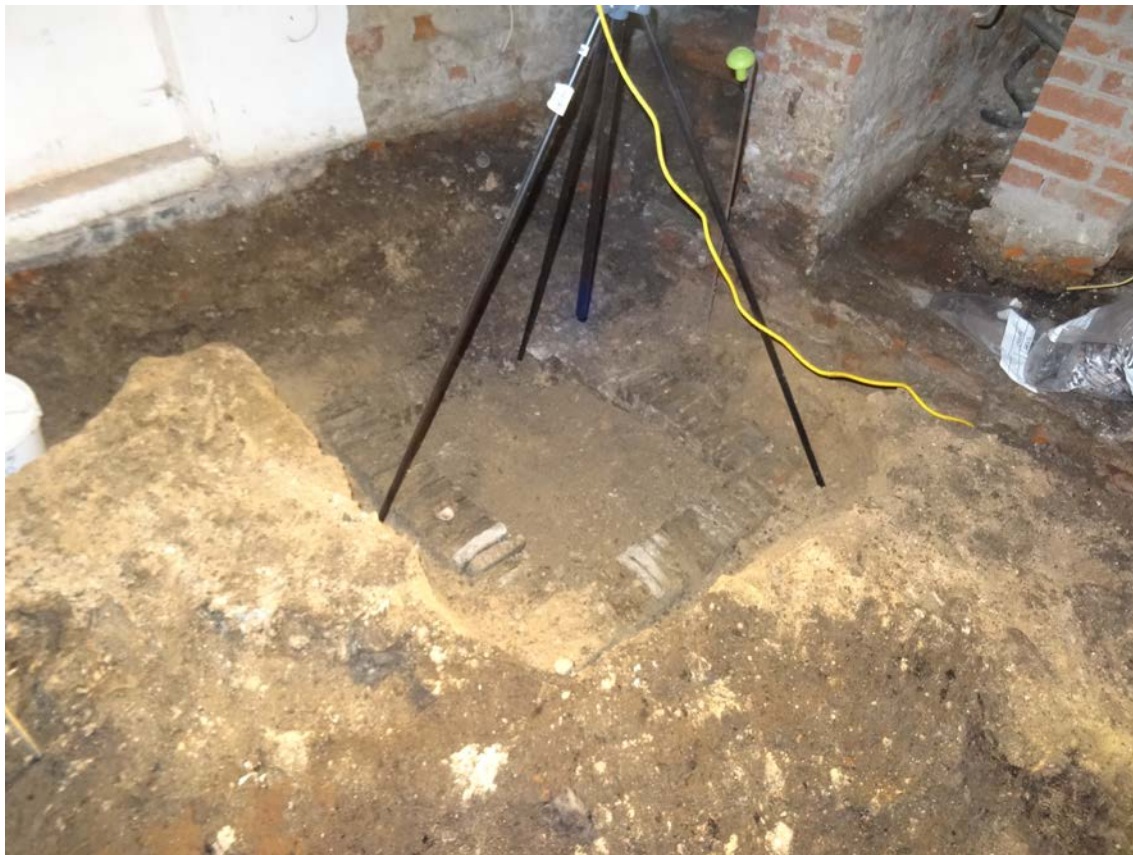
- A Roman structure, thought to be a well has been discovered in the north east quadrant of the west basement.
- Part of a Roman wall has been found in the south east quadrant of the west basement. A further fragment of stone wall, also thought to be Roman, has been found in the south east section of the east basement. These wall fragments may be part of a former building in the civilian settlement named the Colonia which was located on the south side of the river. The fragments of decorated plaster would indicate this was a high status property.

Fig 4. Roman structures in west basement.

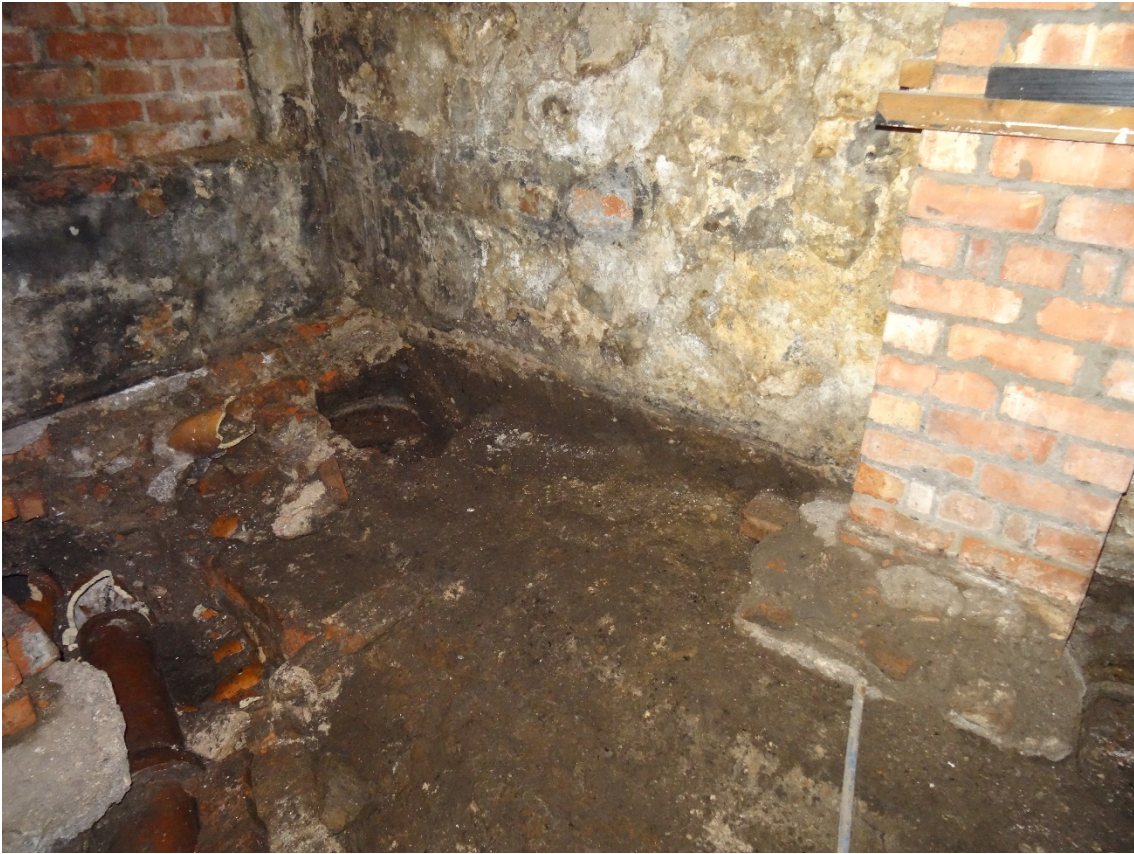
- It has been discovered the majority of basement walls are founded on earth at roughly the same level as the existing floors, to install the new floor slab would require deep excavations that risk undermining the adjacent structures. As a result we have decided to raise the floor levels, this has meant we need to change the basement layout to make better use of the available headroom.
- An old main drainage connection to Micklegate has been found in the north east basement, we wish to retain this connection and install a new manhole in the basement.

Fig 5. Basement walls founded on earth with inadequate foundations.

Layout of new stud walls amended to show new floor levels following discovery that the floor level needs to be raised to secure the existing wall footings without the need for extensive underpinning. This drawing also shows an alternative layout to make use of existing drain to north end of the east basement and make better use of available headroom. In the west basement the floor needs to be locally lowered in the central section to provide adequate headroom under an existing timber beam.
