The Assembly Rooms, Blake Street, York

Statement of Significance

Statement of Significance for The Assembly Rooms, Blake Street, York

Note: This Statement of Significance is focused on the clerestory lantern of the Great Assembly Room, and is intended to form part of a forthcoming wider Statement of Significance on the whole site of the Assembly Rooms, Blake Street, York.

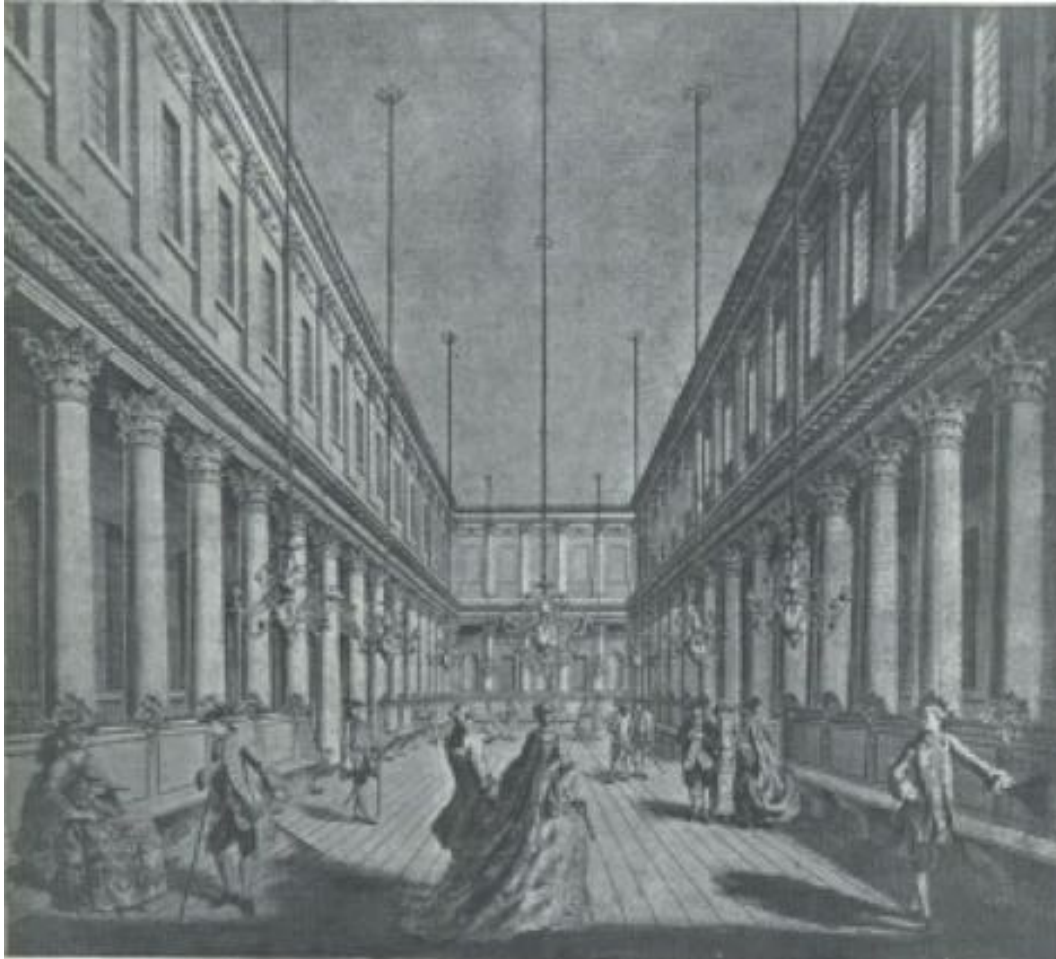
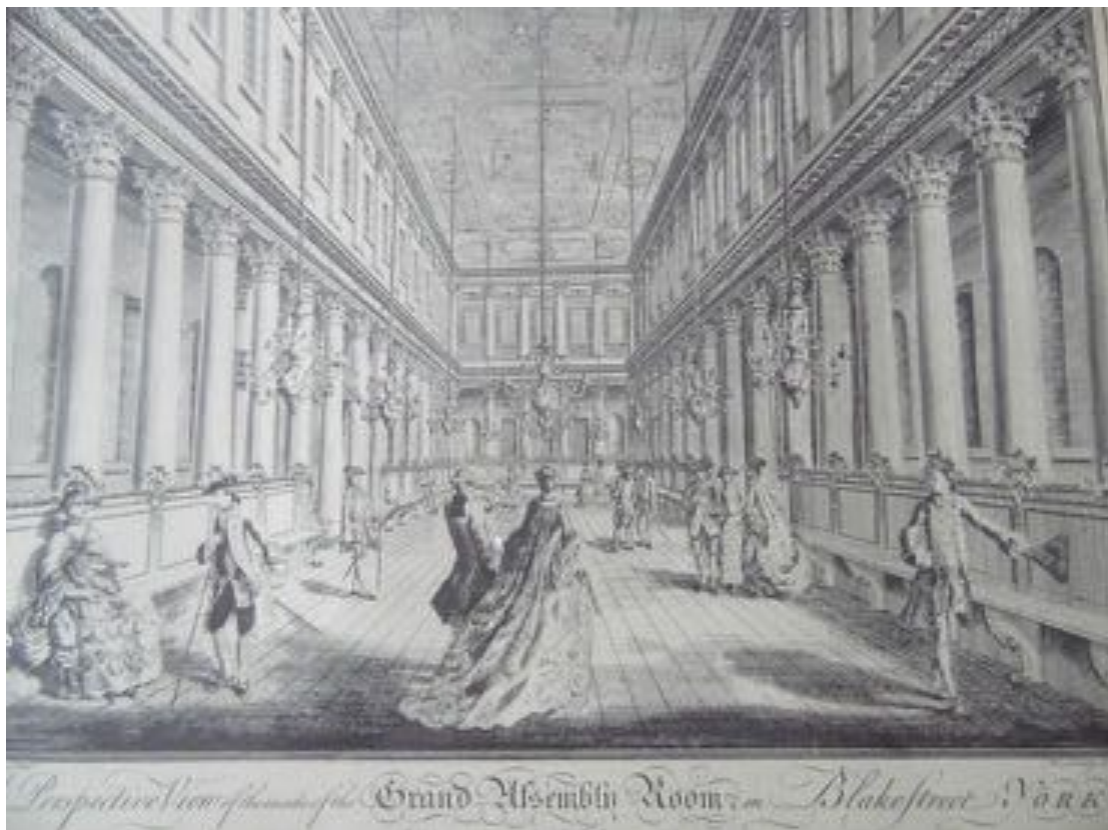
Fig. 2. 1760 Engraving by W. Lindley showing the Great Assembly Room with its plain ceiling.
?? Altered version of the Lindley's 1760 etching including a fanciful Rococo ceiling design.

The clerestory of the Great Assembly Room has a flat white ceiling of lath and plaster above a richly decorated entablature. Versions of Charles Lindley's 1760 etching (fig. 2) show the ceiling with Rococo embellishments, but it was almost certainly always an adorned ceiling.

- An initial order of 6 lustres of crinkled glass was placed in 1731, although this was soon raised to 12 (although only 9 are readily identifiable on the 1760 etching – see fig. 2).

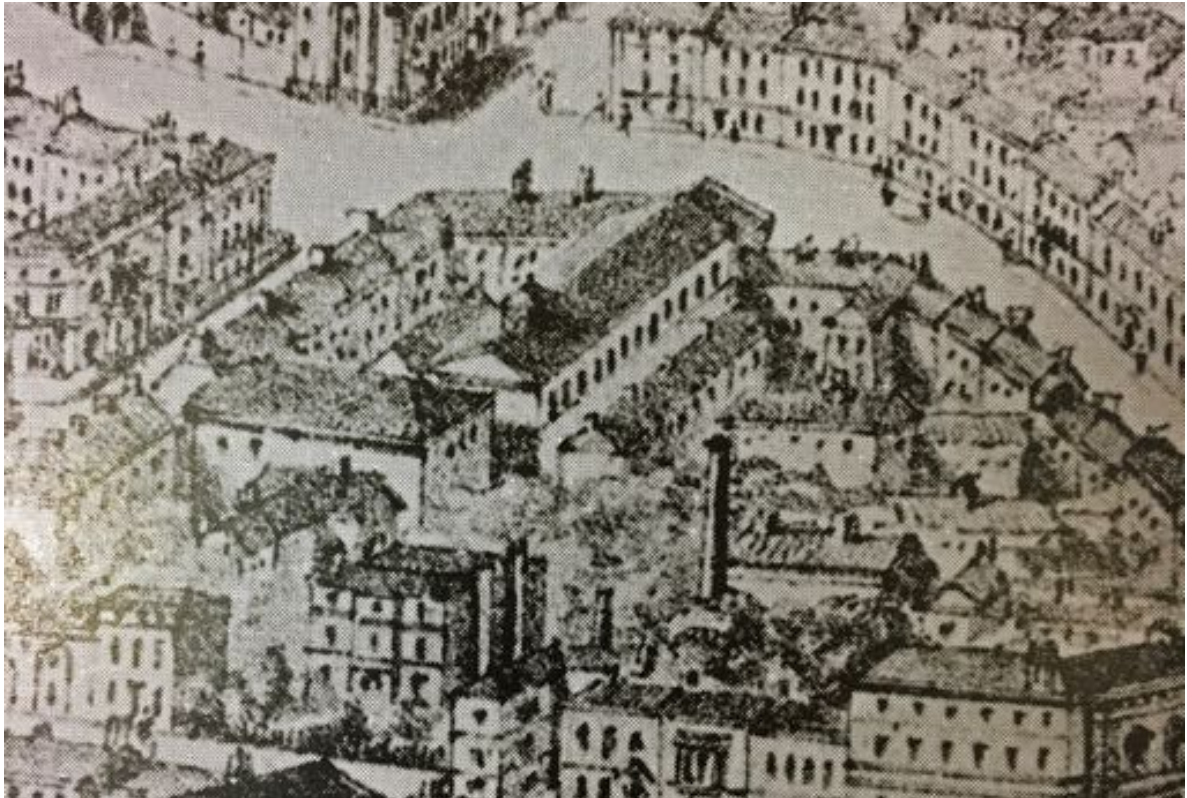
Fig. 5. Nathaniel Whittock's c.1850 view of York, showing the cupola in place - seemingly not in its current position, although this may simply be a perspective error (Murray 1988)

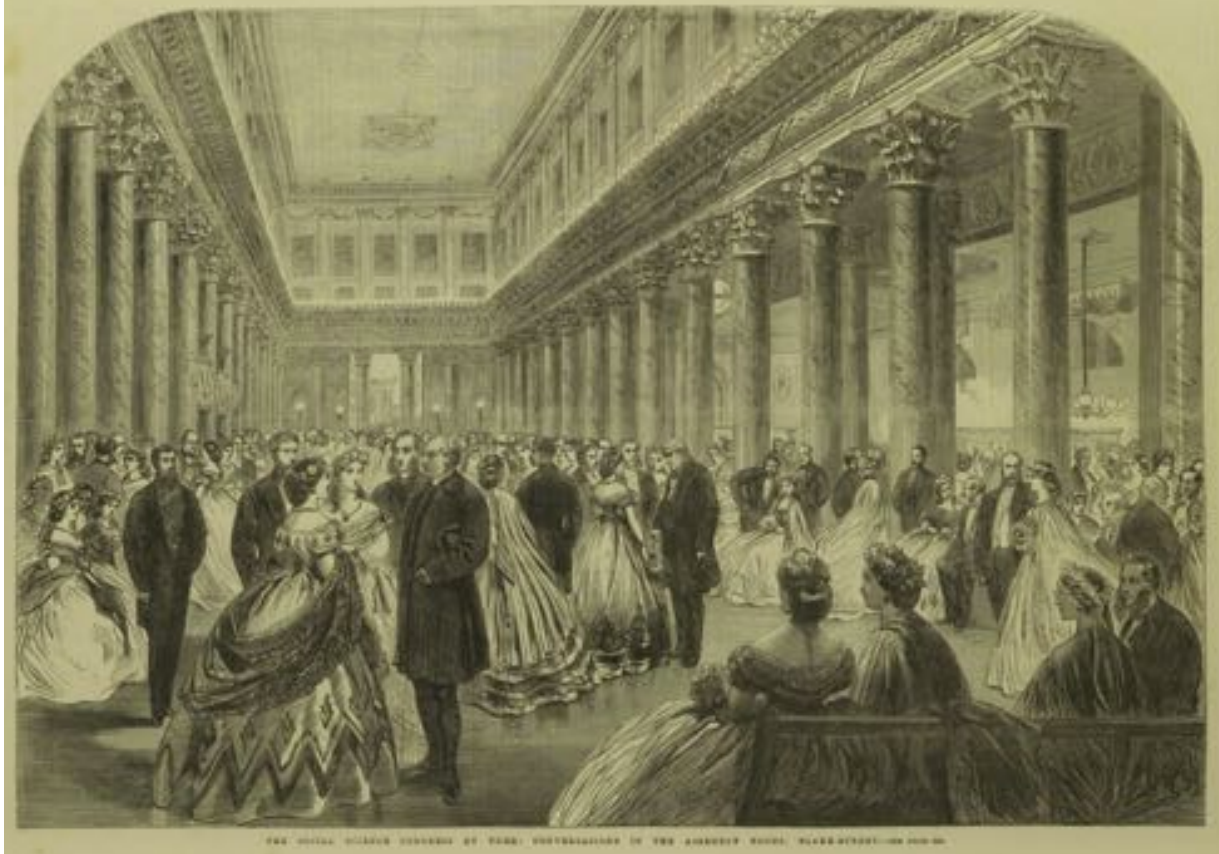
Fig. 7. Image of Assembly Rooms from the *London Illustrated News* (08/10/1864, 20) - note the presence of the vent at the far end of the ceiling, and its surrounding decoration.

- By 1818 Burlington’s grand chandelier had been “removed [to] near the principal entrance” (Hargrove 1818, 471).
- The chandeliers, along with the organ, were sold in 1860. The 1864 etching of a gathering for the Social Science Congress shows the room instead lit by hundreds of candles placed along the moulded entablature (see fig. 7).

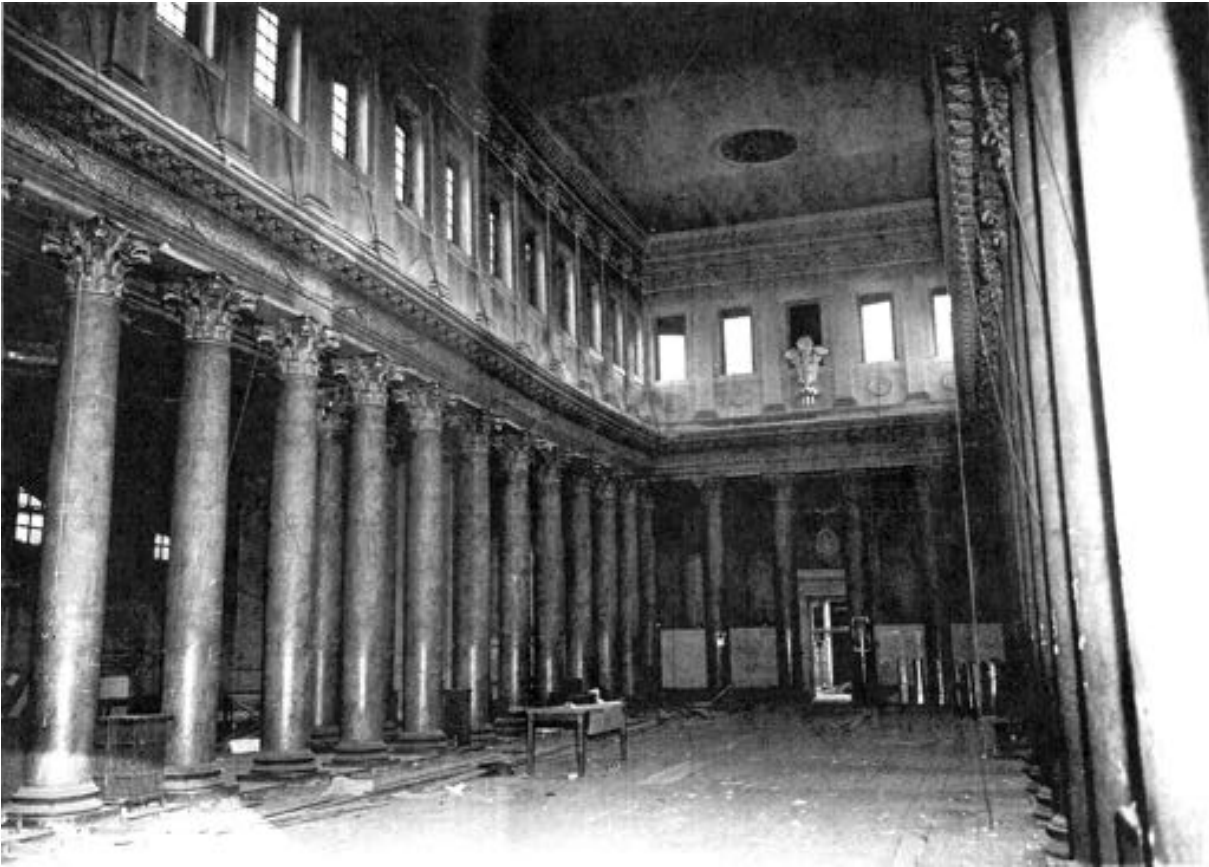
Fig. 9. c1940 photograph of Great Assembly Room interior (looking east) showing the ceiling vent.

- In 1755 John Staveley added a number of decorations of gilded and painted plaster to the interior walls of the clerestory, included scallops above the end windows and oval mouldings below. Removed in 1950-1, these are partially visible in photographs on c.1940 (see fig. 9).

- In the C19, the coat of arms of Queen Victoria was added above the entablature in the centre of the western end, and the feathers of the Prince of Wales opposed it on the eastern end. Queen Victoria's arms survive, but the emblem of the Prince of Wales (visible in fig. 9) was removed in 1950-1.
