FAIRFAX HOUSE

CONSERVATION STATEMENT

July 2014

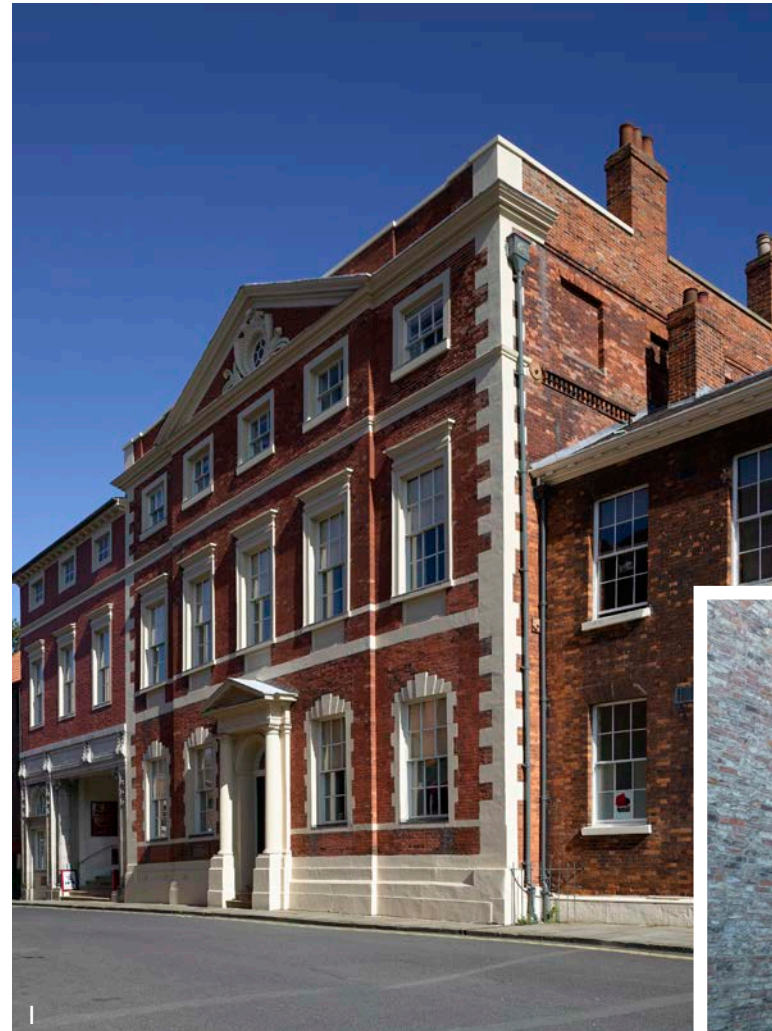
The three storey main house is a grand Georgian building, with elegant proportions and regularly spaced windows. It is constructed of red brick with painted stone dressings. The central three bays of the five bay wide house project slightly and are topped with a triangular pediment containing a stone oculus in a carved stone surround. The main door of the house (little used at present) is located in the central bay of the ground floor under a Classical doorcase.

- 1 The main elevation of Fairfax House (courtesy of Fairfax House)
- 2 The two entrances to the rear of the building

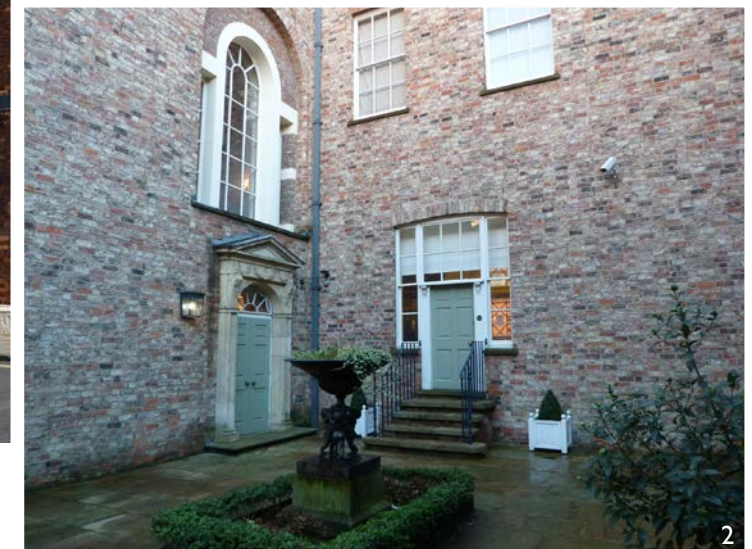
The rear elevations of Fairfax house are simpler in design to the front. The elevations are all red brick, which were completely refaced in the 1980s restoration. There are a number of sash windows, with a larger Venetian window (consisting of two small windows flanking a central arched window) over the rear door to the main house. This door has a Classical stone doorcase. A second rear door is situated in the back of the former cinema block, up a short flight of steps.

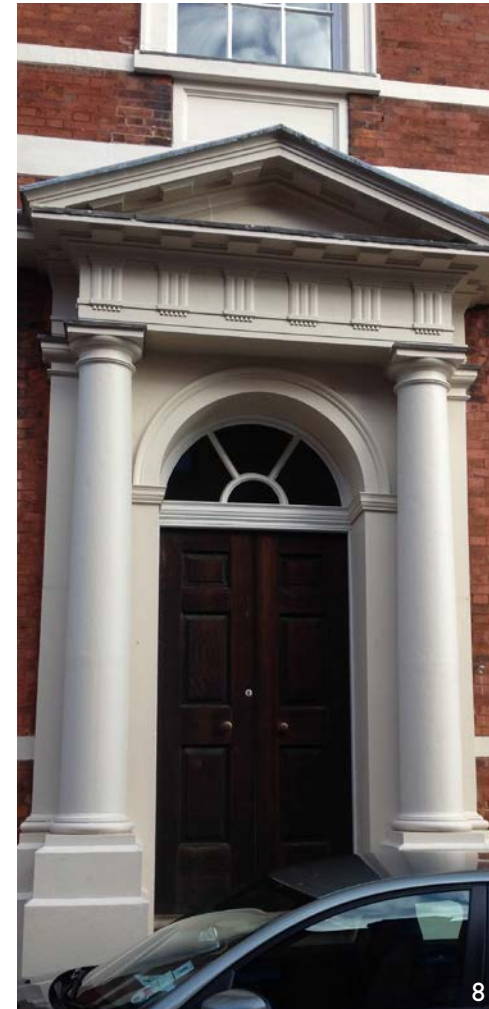
- 3 The rear elevation within its setting
- 4 No.29
- 5 The rear elevation of the entrance block
- 6 The front elevation of the entrance block
- 7 The rear elevation of Fairfax House
- 8 The Classical doorway to the front elevation of the main house

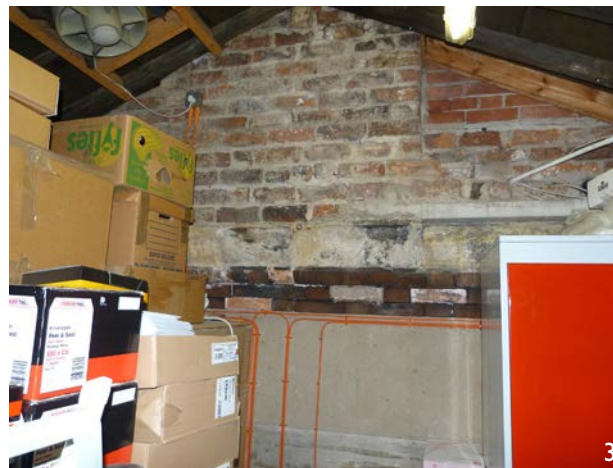
The space above the exhibition room is an attic store set within the roof void. The roof timbers of the 1920s cinema building are exposed. Modern blockwork walls have been added under the eaves of the roof. The south-east wall is formed of the formerly external brick wall of the main house. Parts have been rendered over but some of the brick wall and the moulded stone cornice (though in poor condition) is also visible.

- 1 The entrance hall, looking towards the reception desk, door through to the main house and staircase up to the exhibition room
- 2 The first floor exhibition room looking north-west (courtesy of Fairfax House)
- 3 The attic store showing the formerly external wall of the main house with stone cornice
- 4 The library looking north

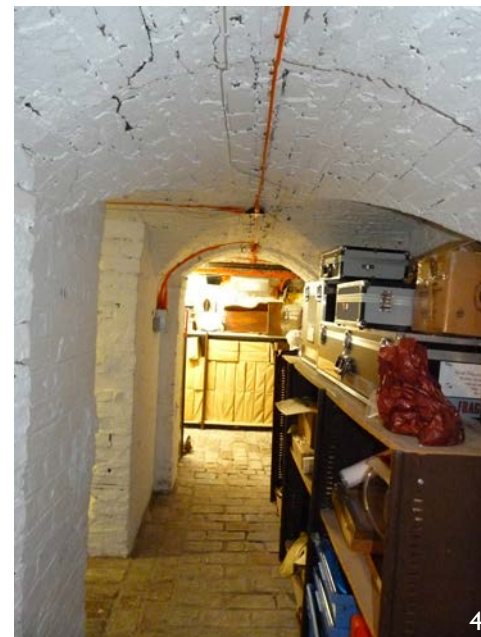
A series of narrow vaulted cellars are located under the main house, accessed from under the rear stairs. These are brick barrel vault construction with a brick floor (re-laid over concrete in the 1980s). Historically, these were likely to have been used for storage, possibly for coal and for wine which needed to be kept at a cool temperature. The current entrance under the back stairs was created in the 1980s. The original entrance was under the main stairs and the original opening can be identified.

- 1 Anne's Bed Chamber looking north-west (courtesy of Fairfax House)
- 2 The north-western office on the second floor
- 3 The living room in the second floor flat
- 4 The vaulted brick cellars under the main house
- 5 The attic above the main house

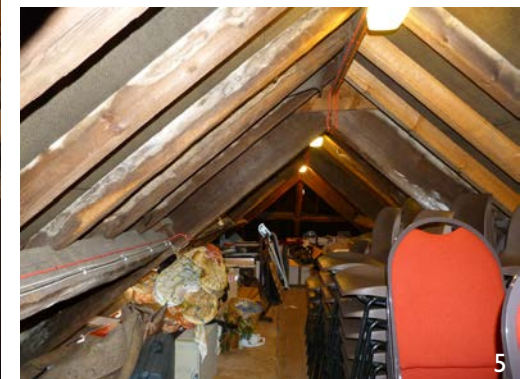
The attics of the main house are accessed via a central staircase on the second floor. They are laid out in a 'U' shape around this central staircase. The exposed roof timbers are a mixture of original and 20th century replacements. Some historic brick partitions and chimney stacks are visible. The inside face of the pediment on top of the main elevation of the house is also visible. It is clear that it has been rebuilt in the 1980s as it is constructed in blockwork. There is evidence of an original window on the south-east wall, now blocked up. The attics are currently used for storage.

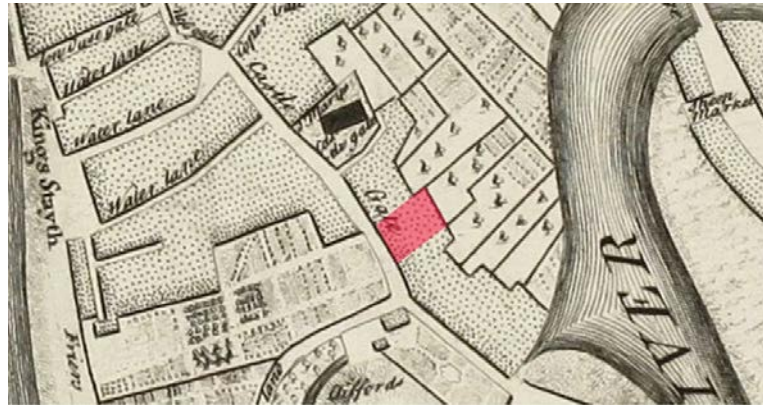
1750: John Rocque

A map of York surveyed by cartographer John Rocque shows the north side of Castlegate as heavily built up with large gardens extending north-eastwards towards the River Foss. The area opposite the house was laid out as a series of allotments or garden plots. The house which was later turned into Fairfax House as we know it today is marked in red on the plan.

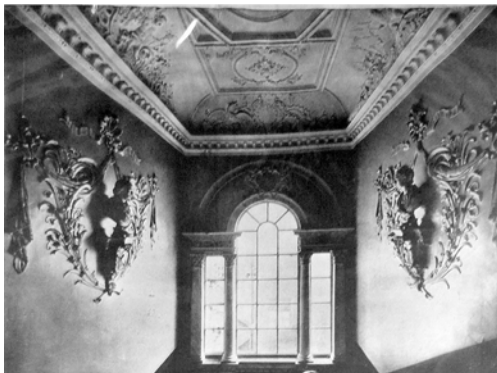
Venetian window, early 20th century (York Civic Trust)

A photograph of the principal staircase shows the Venetian window before it was bricked up in 1919 because of the cinema extension constructed adjacent. (see *1919: Cinema and Dance Hall*).

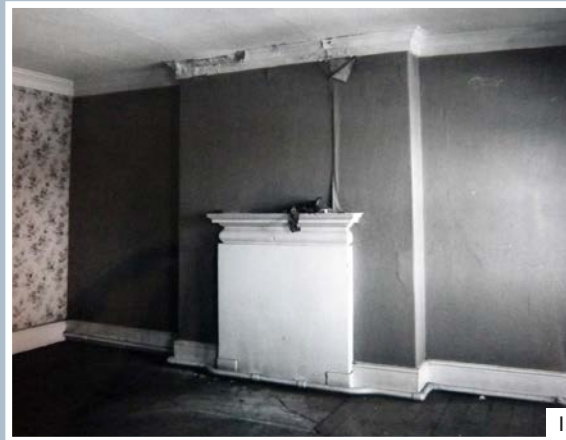
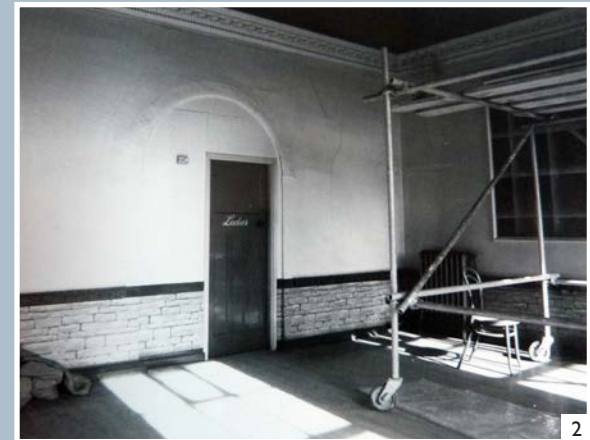
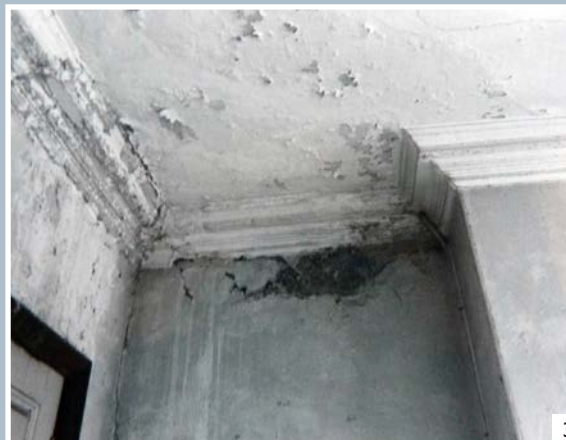
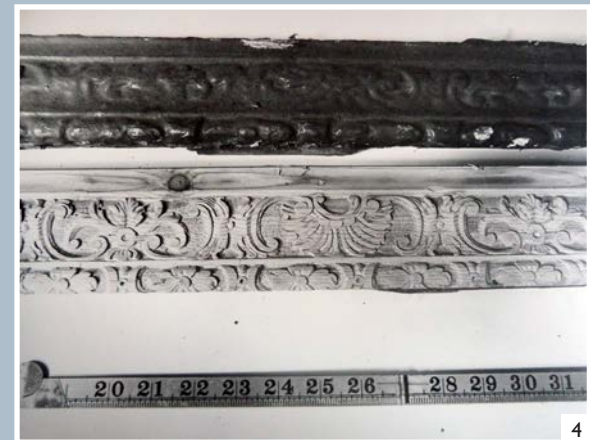
- 1 A second floor room before restoration (York Civic Trust)
- 2 Drawing Room before restoration (York Civic Trust)
- 3 Damage paintwork (York Civic Trust)
- 4 Dado rail restoration in progress (York Civic Trust)

An estimated 20,000 hours were devoted to cleaning the decorative plasterwork; £45,000 was spent stripping the ceilings and cornices alone. The intricate carving throughout the house had become clogged with decades of thick paint and the relief all but lost. This was stripped back to reveal the bare carving before being repainted. Restoration documents make reference to paint scrapes which implies that paint analysis was carried out at this time to inform the redecoration work, though any results of this analysis were not found during the research for this Conservation Statement.¹⁵

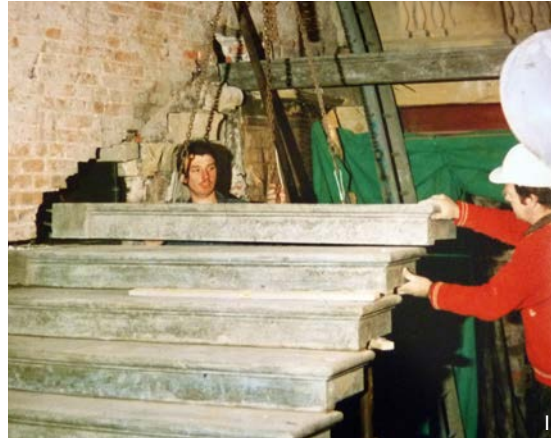
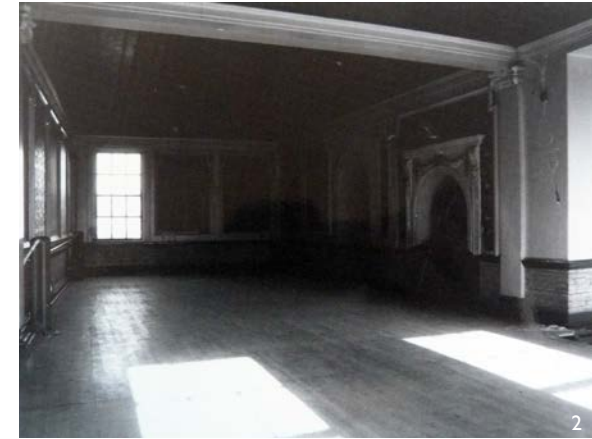
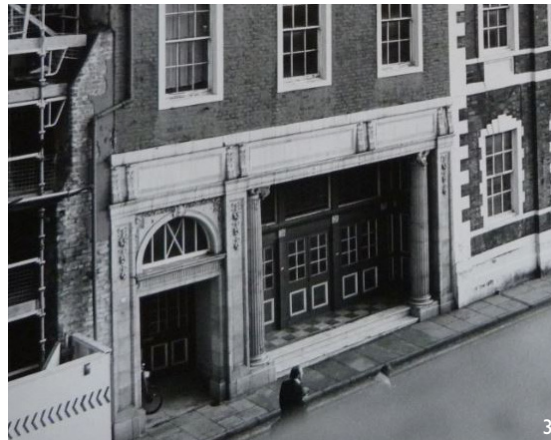
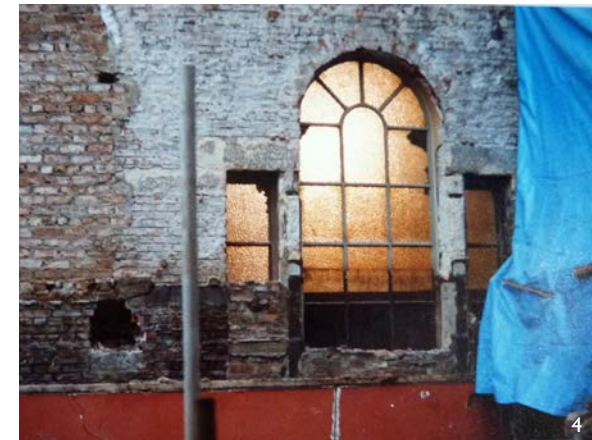
- 1 Reinstating the portion of second staircase (York Civic Trust)
- 2 The Exhibition Room before the Saloon wall was re-instated (York Civic Trust)
- 3 The cinema entrance façade before the 1980s restoration and replacement of the flat door screen with a curved version (York Civic Trust)
- 4 Re-opening the Venetian window (York Civic Trust)

The front elevation was severely weathered in places, most notably where a soft stone had been used in the detailing and had subsequently worn away. The 1920 cinema had been built in a sympathetic style, echoing the 18th-century fenestration, and a clue to the building's former use survived in the form of a large painted sign on the north gable end. Part of the ground floor façade was, however, rebuilt, which altered the entrance way from a flat screen to a curved one (see image 3).

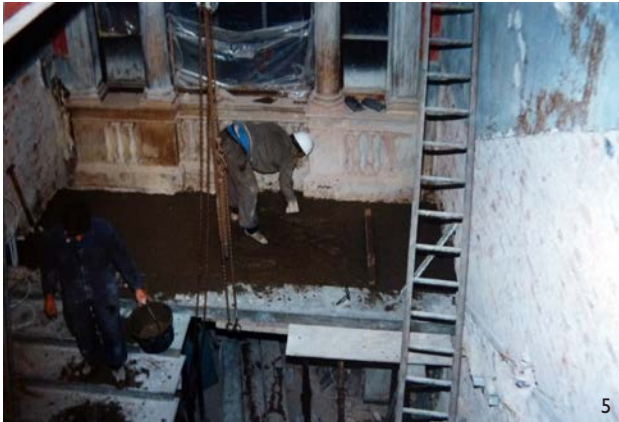
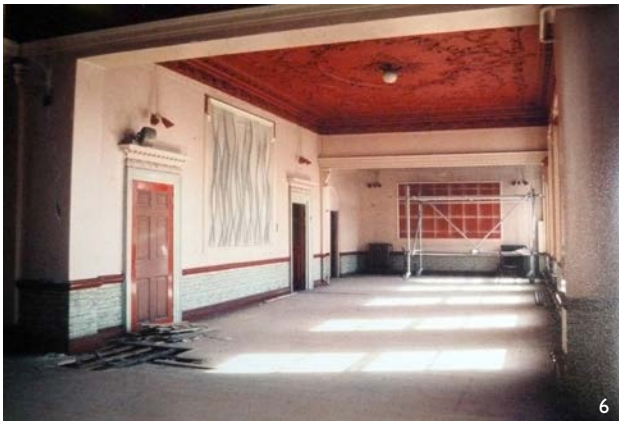
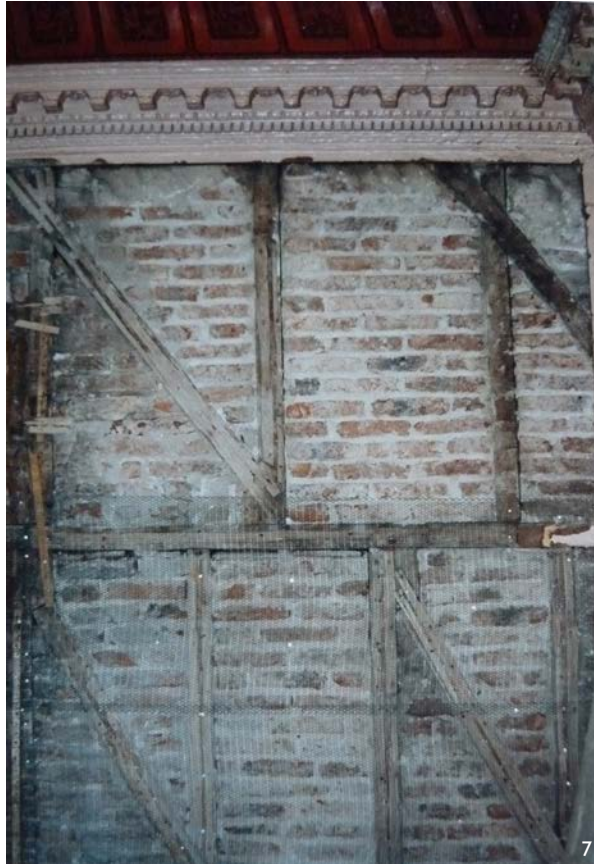
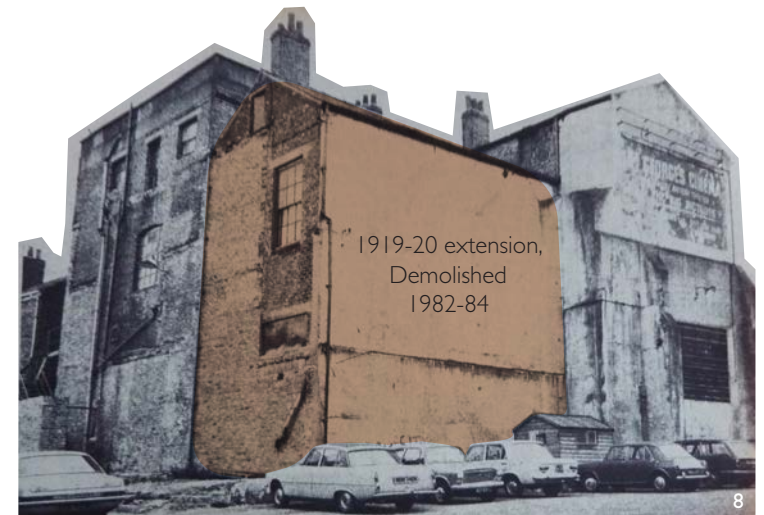
- 5 Re-enforcing the principal staircase (York Civic Trust)
- 6 Saloon through to the Drawing Room (York Civic Trust)
- 7 Revealed brick and timber wall (York Civic Trust)
- 8 1919-20 rear elevation before partial demolition (York Civic Trust)

The opening up of the first floor to create a dance hall on the Castlegate side of the building had weakened the 18th-century structure and meant that original walls, doorframes, cornices and two fireplaces had been lost. The lost partitions were re-instated, together with new mahogany doors, and period-appropriate fireplaces were installed in the Drawing Room and Saloon. The men's WCs on the first floor were removed and the room restored to its original dimensions to create a reproduction bedroom (the Viscount's bedroom today). The principal staircase, worn and weakened by decades of dance hall patrons, was repaired and reinforced with RSJs. Portions of the secondary staircase at the back of the house were also repaired.

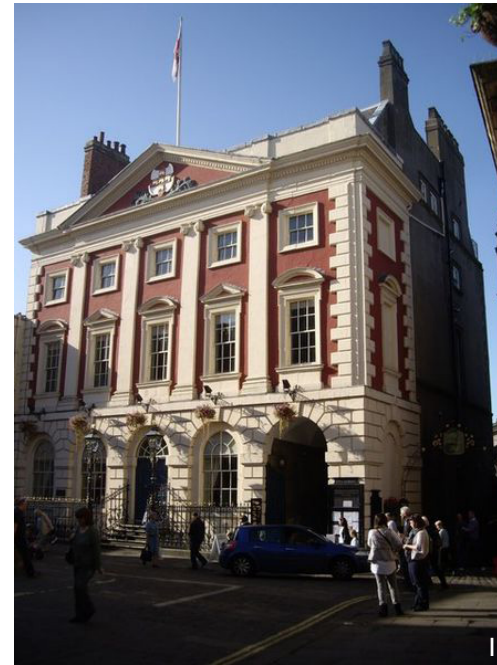
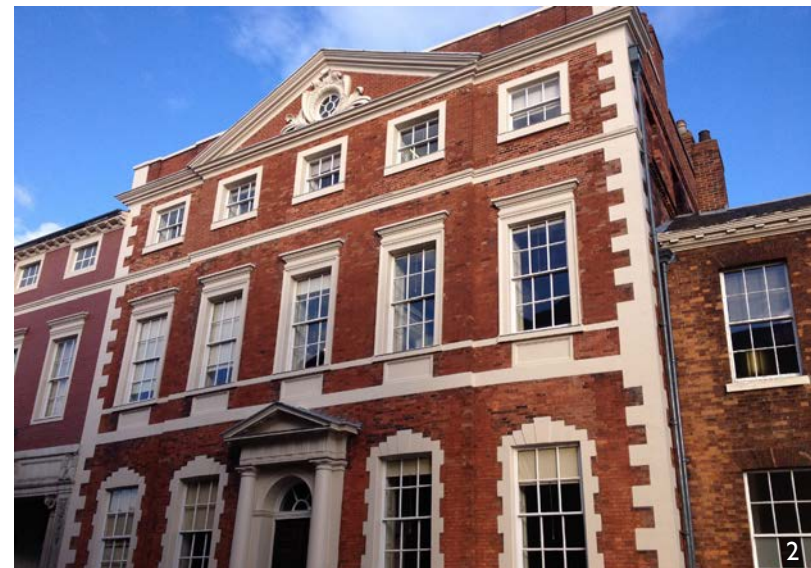
1 The Mansion House, St. Helen's Square, York, 1725 (© Stanley Howe)
2 The principal façade of Fairfax House

Typical Georgian houses in York were built of red brick with stone dressings. They used Classical proportions with regular façades containing sash windows and Classical detailing. The Mansion House is one such example. It was built as a house for the Lord Mayor in 1725 and is constructed of painted brick with painted stone dressings. Like Fairfax House the building is three storeys high and five bays wide. Both feature sash windows, quoins and a central pediment, though Mansion House is slightly grander because of its high status as a public building.

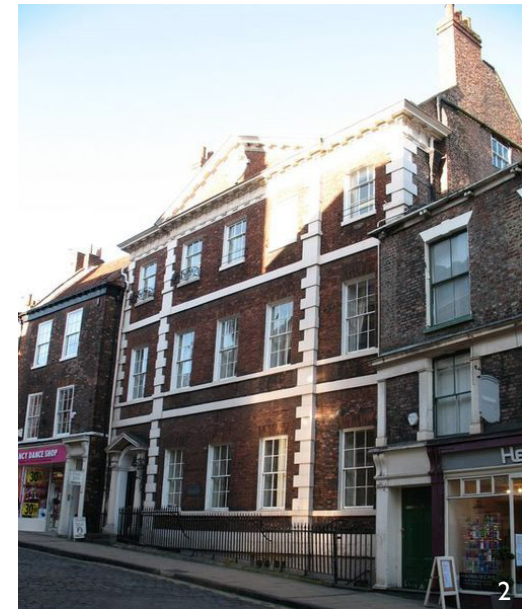
- 1 Castlegate House by John Carr, 1762-63
- 2 Garforth House, attributed to John Carr, c.1755-57
(© Gordon Hatton)

Externally each displays the typical Georgian characteristics and are built with red brick and stone dressings.

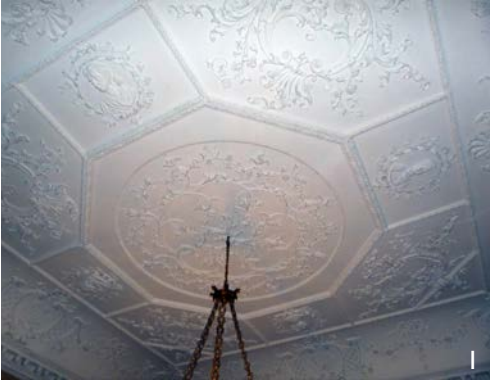
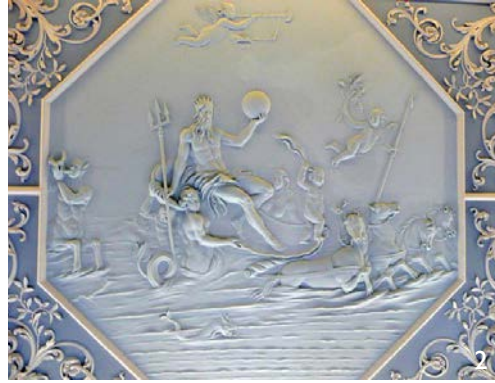
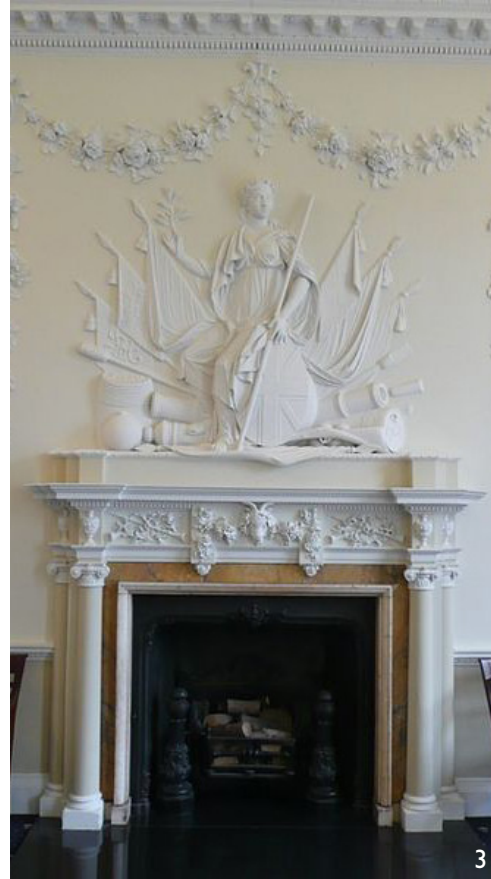
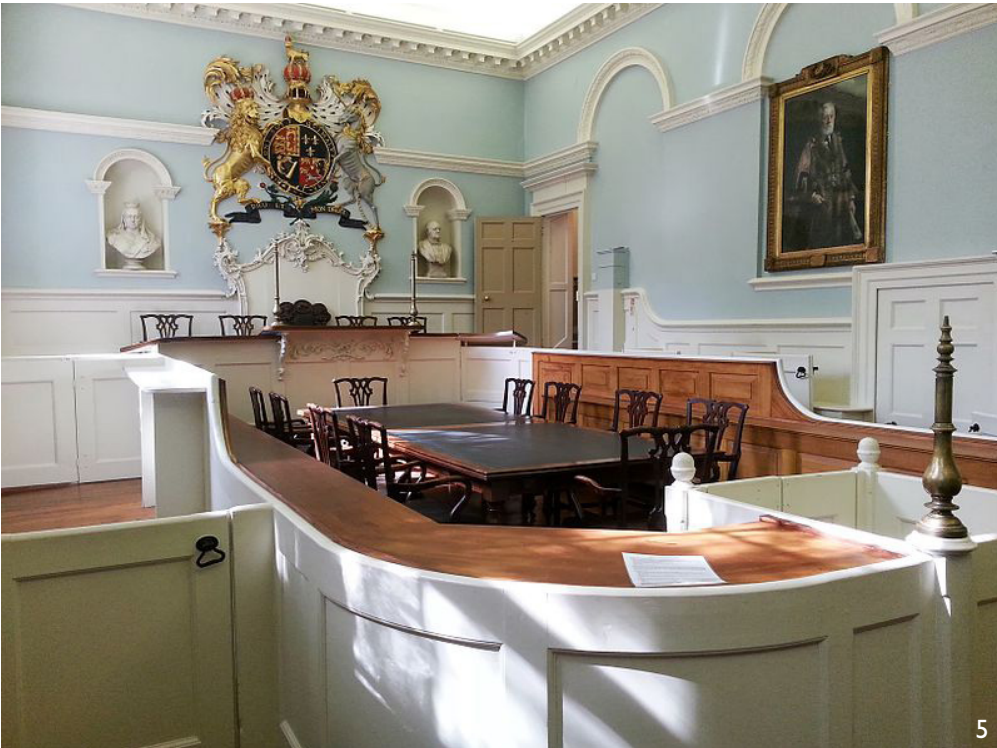
- 1 Plasterwork in the Library at Fairfax House
- 2 Neptune, Somerset House, Halifax, by Cortese (© Humphrey Bolton)
- 3 Britannia, Somerset House, Halifax, by Cortese (© Humphrey Bolton)
- 4 Detail of the carving above one of the doors on the main stairs.
- 5 The Guildhall Courtroom, Beverley, by Cortese (© Mjr511)

The Conservation Area Appraisal describes Carr's work in York: "Local architects, none more so than John Carr, oversaw the construction of houses characterised inside and out by high-quality detailing such as joinery and plasterwork, produced by highly-skilled local craftsmen according to identifiable local styles. For example, a 'York School' of plasterers, some of whom were Italian craftsmen, produced exuberant 'Rococo' plasterwork."²

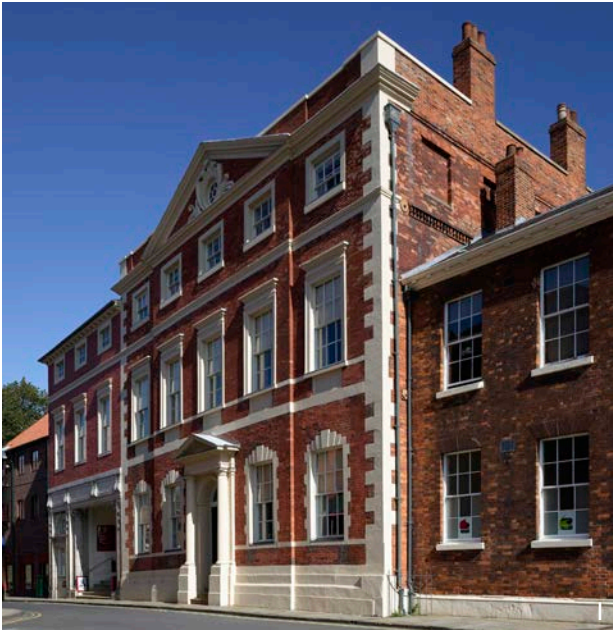
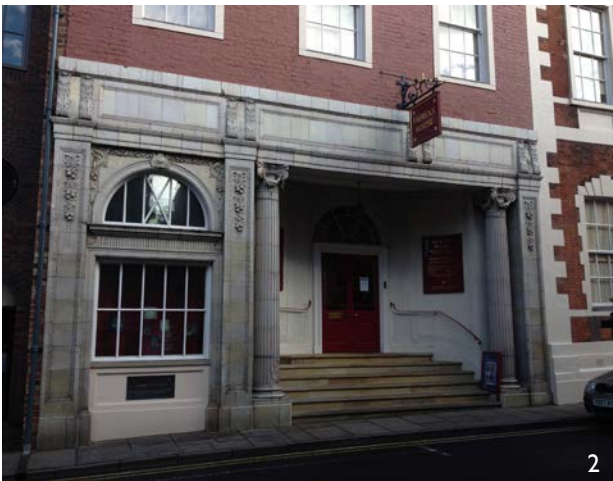
1 The front elevation of Fairfax House on Castlegate (courtesy of Fairfax House)

2 The 1920s cinema entrance

The cinema extension from the 1920s has an elaborate ground floor, which demonstrates some of the opulence and enjoyment of visiting the cinema. The upper floors were designed in a Georgian style and matched the proportions of the adjacent main house, meaning the extension is sympathetic to the original block.
