60 Goodramgate, York

House History Research

File: 3190-2021-001

Maybank Building Conservation LLP

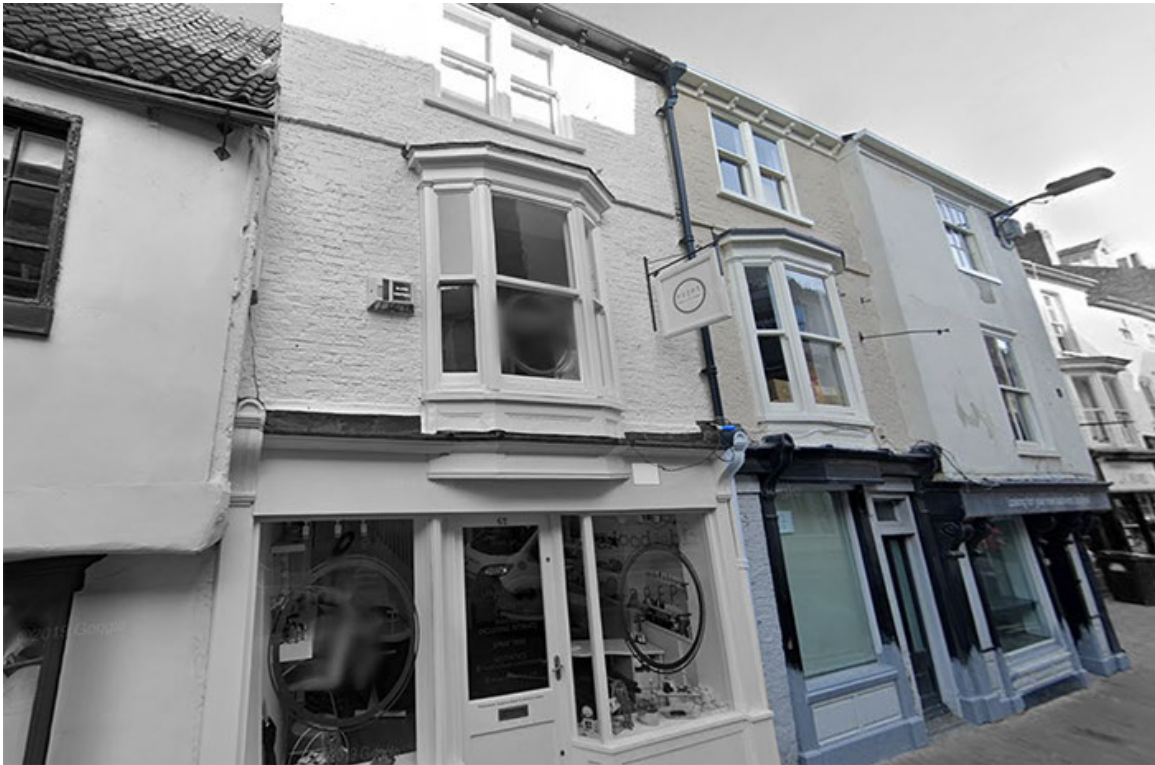
Fig. 5.2 Two main front elevations of no. 60 Goodramgate to right, with no.62 and Lady Row to the left.

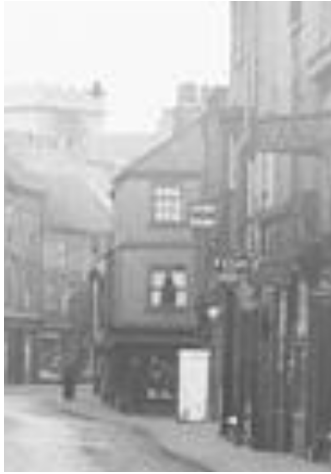
Fig. x Detail from a 1930s photo, showing the return elevation of the site, with curtains in the upper windows, and seemingly decorated in a darker paint colour than today including distinctive sill bands (© York City Archives).

- Bernard & Hannah Margaret Young werelisted at no. 60right in 1932 and again in 1936 (fig. x). There is no record of either property being occupied in the 1939 register.

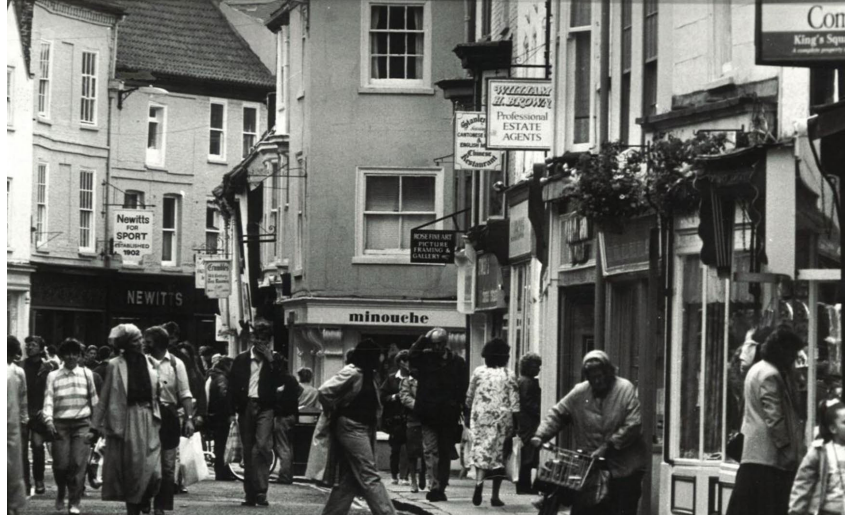
Fig. x Photograph looking south-west from 1988, showing the return wall of No.60 looking much as it does today. The shop was then occupied by Minouche, a childrens' clothing store (© York Press).

- In the later C20th, the site was occupied by a range of specialty retail (fig. x), including clothing, shoes, and most recently as a jewellers, with the upper floors utilised for storage.
- A number of small changes were made to the fabric of the buildings in the later C20th, including changes to the flooring, and the insertion of a shop window into the blind wall of the northern recess.
- The site was bought by the York Conservation Trust in 2001, and in 2006 the small brick lean-to extension (fig. x) was rebuilt to house air conditioning units.

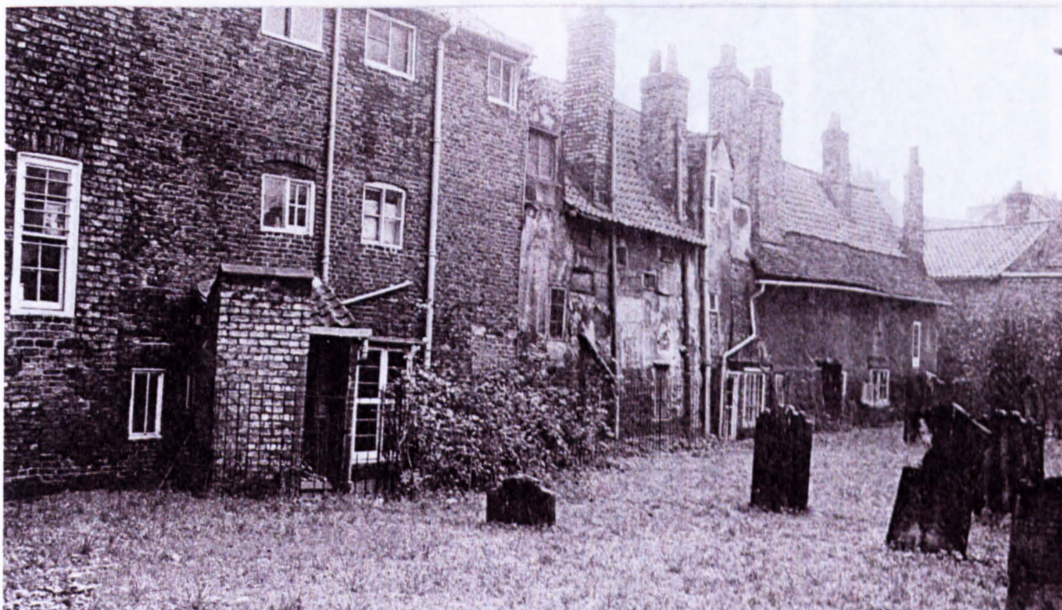
Fig. x Historic photograph (late C19th?) of the rear of the site, showing the brick lean-to prior to rebuilding (© Historic England).

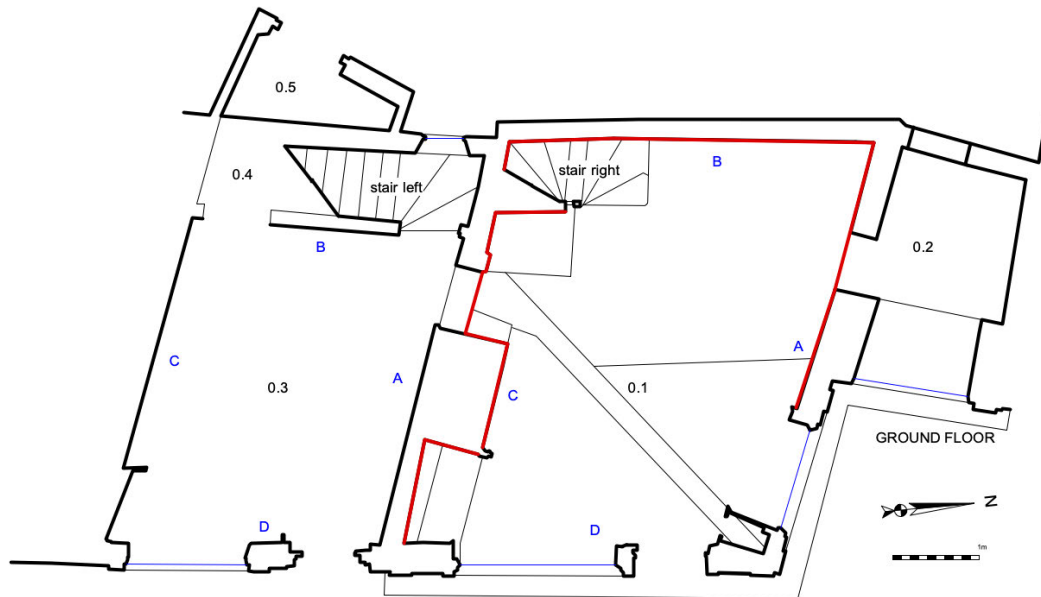
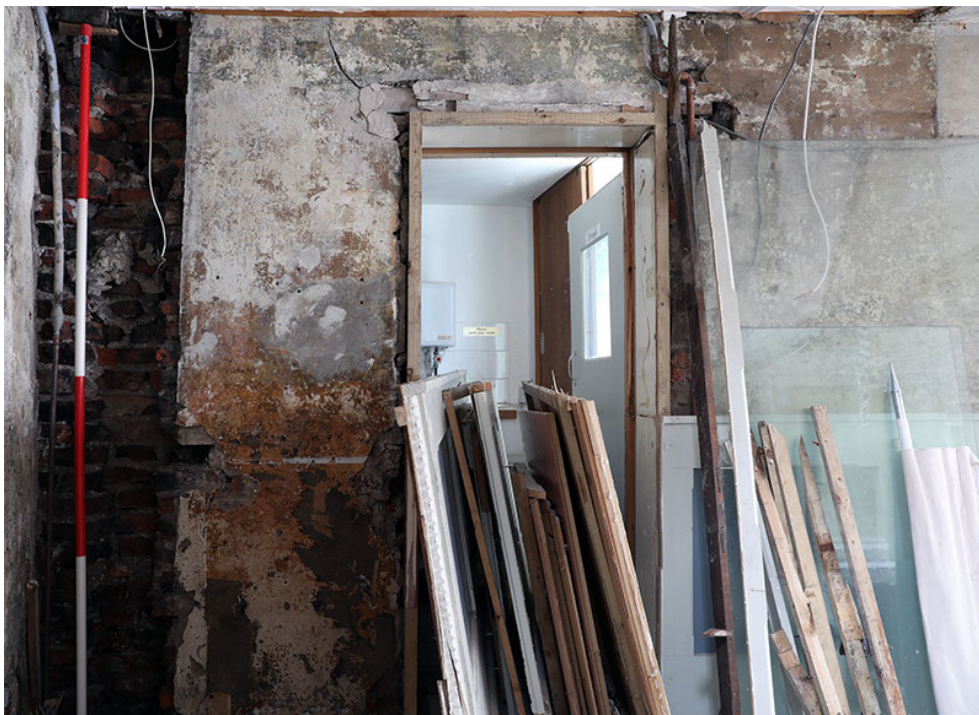
Wall A

- Room 0.1 represents a ground-floor commercial space (no. 60right), and behind the modern shop-fittings, a near-complete historic paint scheme survives. This scheme survives best on Wall C, which features an aquamarine green above the dado level and a medium brown below. This arrangement is reversed on the staircase, which also features an azure green dado fillet.

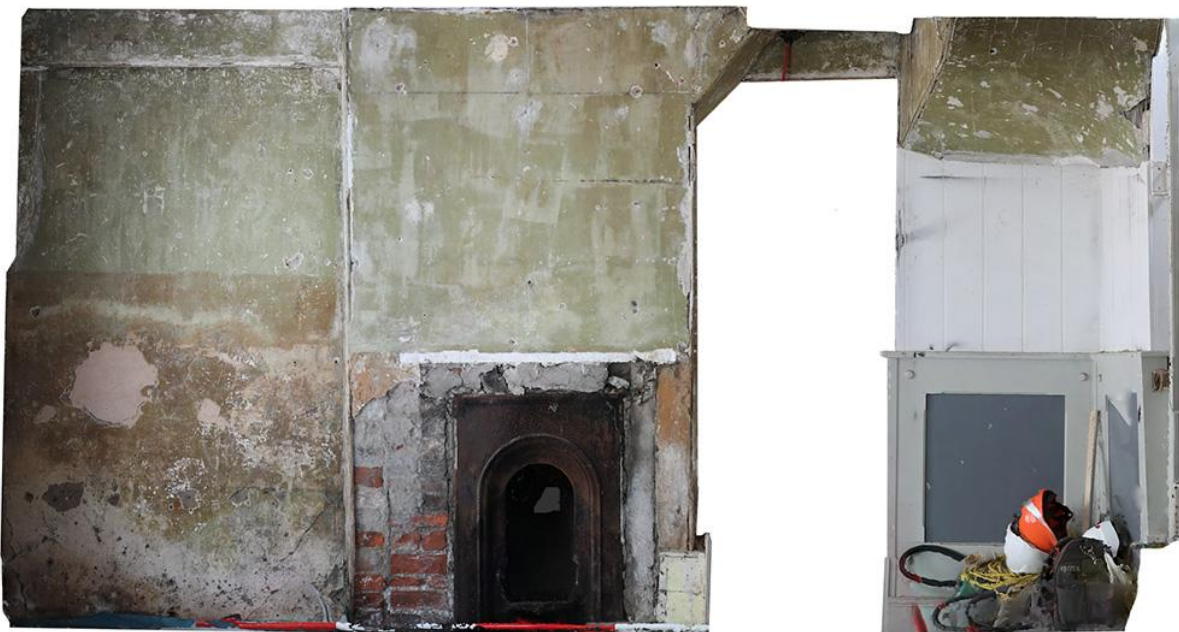
Wall C chimney returns (left and right)

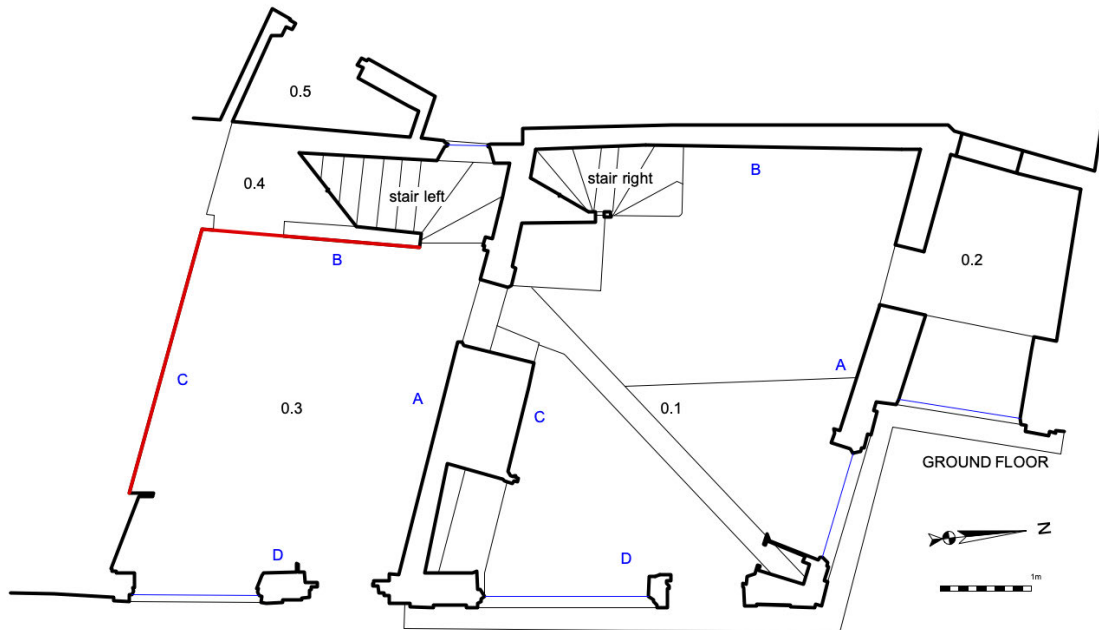
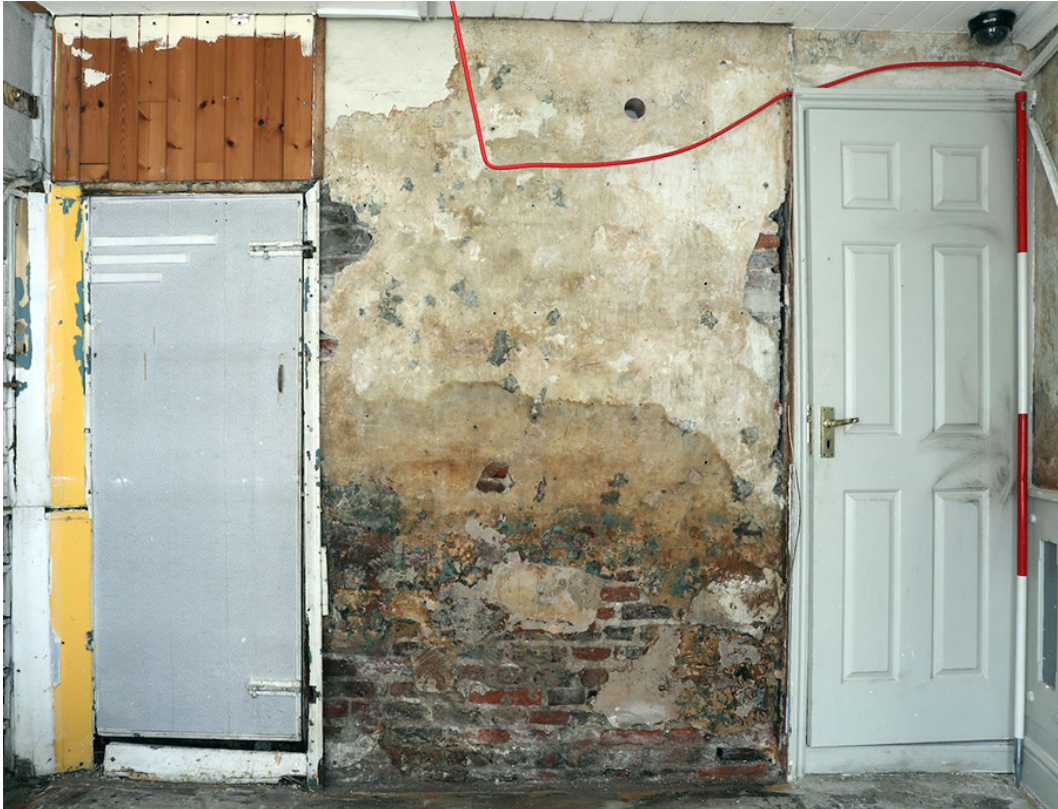
Wall B

- Room 0.3 represents a ground-floor commercial space (no. 60right), and behind the modern shop-fittings, elements of historic paint and wallpaper survive on Walls B & C. The latter includes a cast-iron range. The door to the understair cupboard (0.4) is covered with wallpaper featuring tiny white flowers on a blue background. There is evidence that this survives behind the timber boarding above the door, and above the cupboard space on Wall C. Parts of the door frame are painted a marine blue, below a later yellow. There is fragmentary evidence of at least one scheme of rich blue paint on Wall B, likely only below the dado rail. There is evidence of multiple paint schemes on Wall C surrounding the fireplace opening. The floor surface of Room 0.3 is mostly of quarry tile, however the area within the front window is brick.

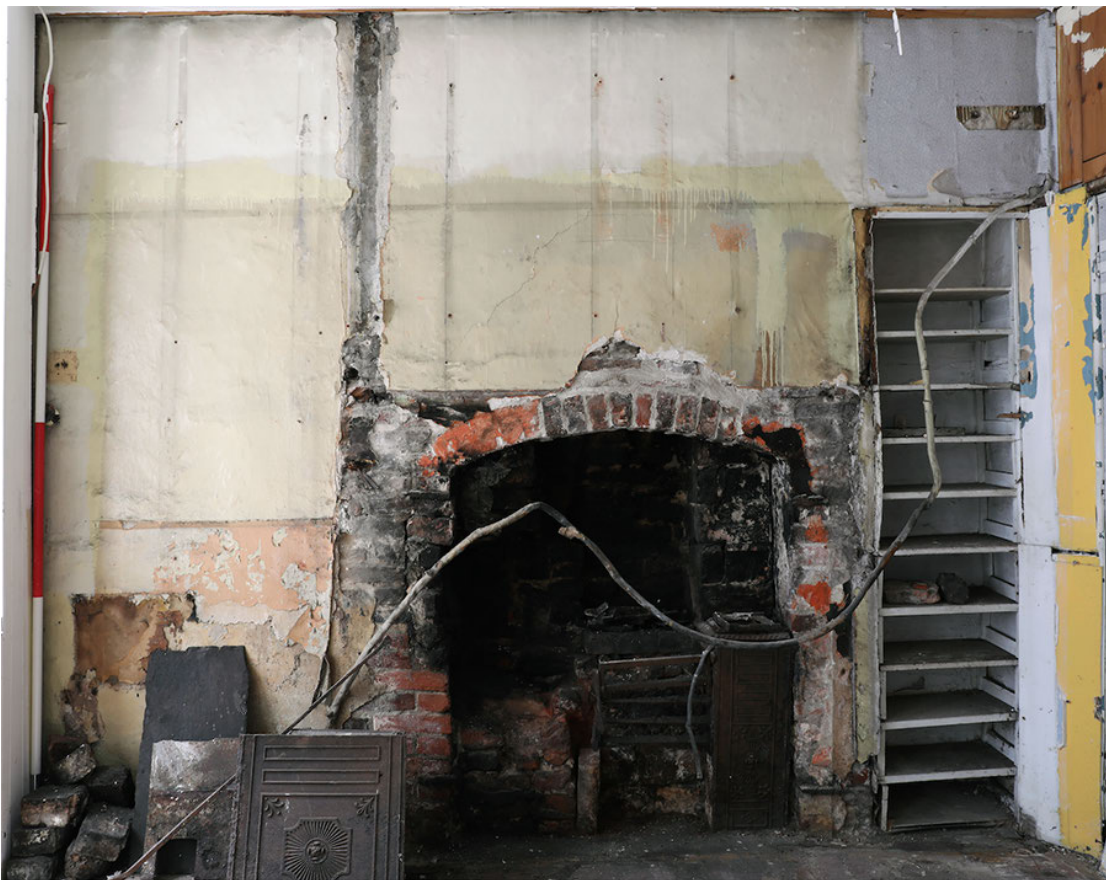
Wall C

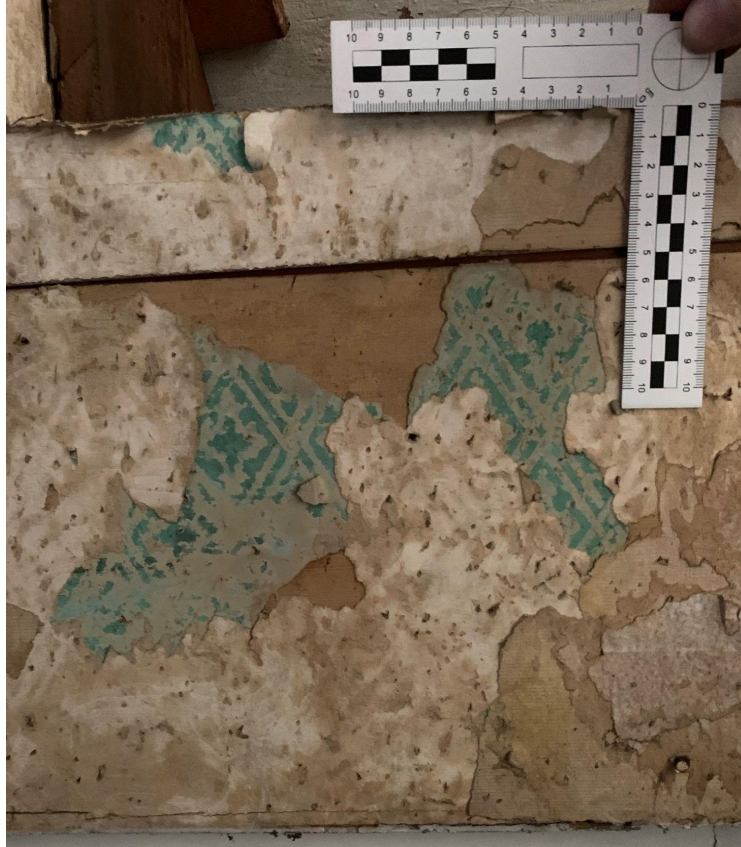
- The small cupboard below the stairs, which once connected through to the range extension, retains evidence of historic wallpaper on the backs of the stair risers featuring a marine blue geometric pattern on a light blue background.

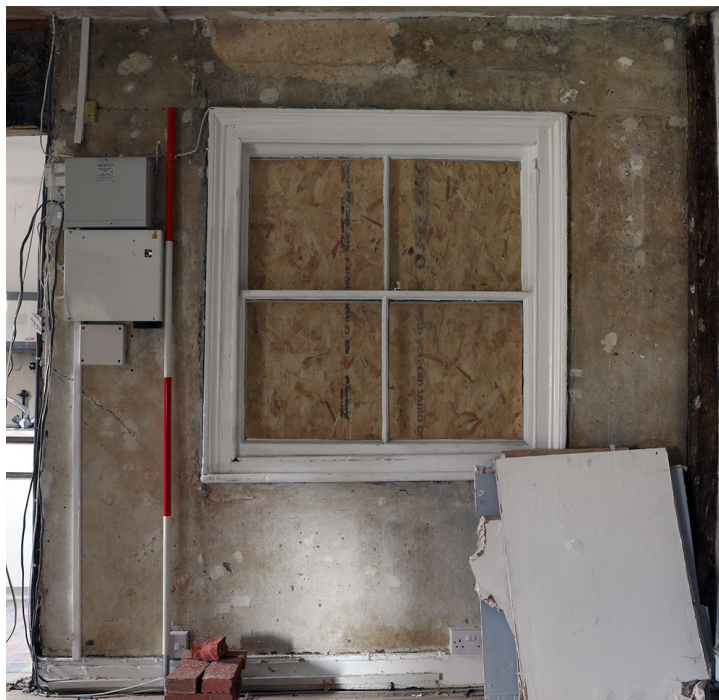
Wall A

- This large space was likely previously two rooms, and formed the first floor of no. 60right. Historic plaster finishes survive, but the only real evidence of any historic decorative scheme can be seen on the chimney breast on Wall H, which features a dark blue up to picture rail height. The lack of paint on the other walls suggests these were likely covered in wallpaper, all traces of which have been lost. Distemper or limewash survives on the ceiling, and the large timber boards boxing out the staircase are bare timber. The decorative scheme of the staircase continues from below and survives well at this level.

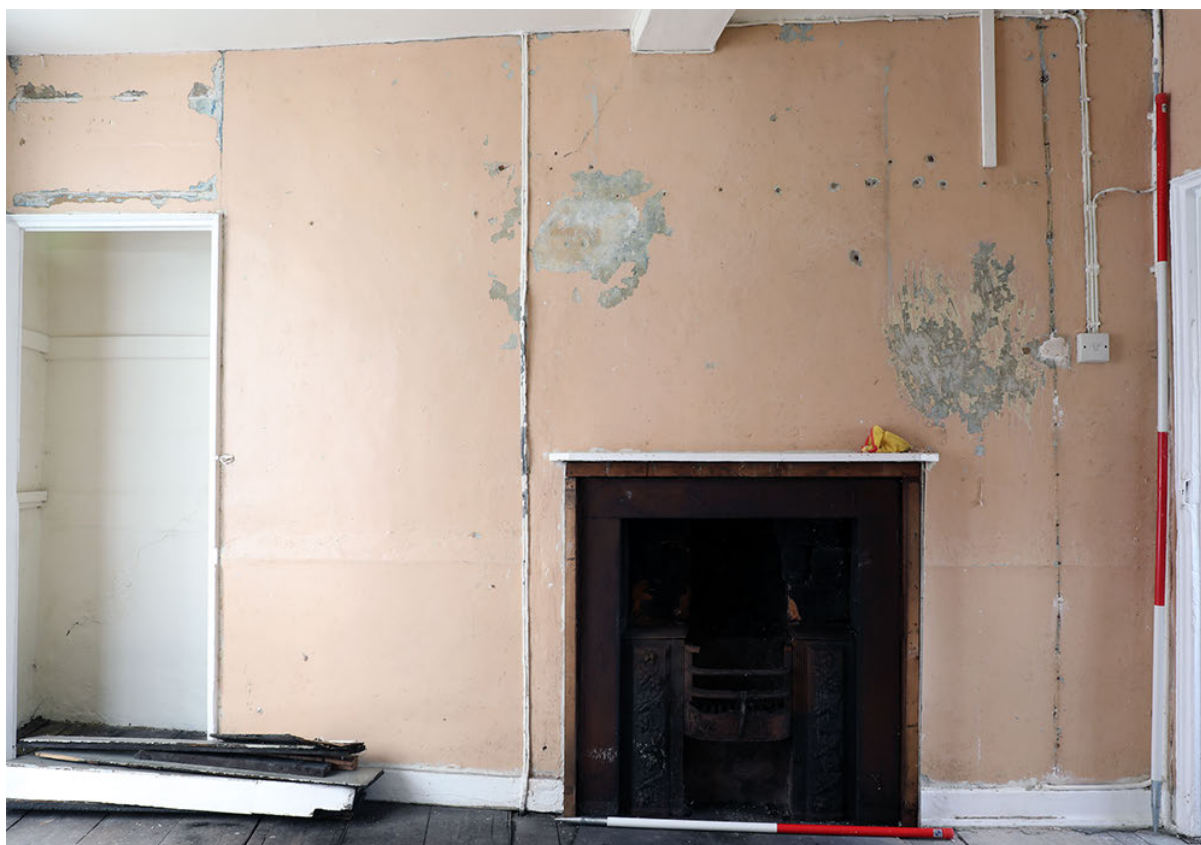
Wall C

- The first floor of no. 60left was the site of the fire in 1888, which affected Wall D. During recording, most of the walls of this room were still covered by modern paint, obscuring any earlier decorative schemes. There is some evidence of a possible light blue scheme on Wall C, and a richly patterned floral wallpaper fragment was found within the cupboard.

- The presence of marine blue in room 1.2 may be indicative of this scheme post-dating the fire of September 1888 in that room.
- The green and brown scheme found in no. 60right likely dates from a period of separate occupancy, either c.1895 or c.1903. The painting of separate colours above and below dado level, and the use of a colour dado fillet on the staircase (right) are very common in the C19th and early C20th.

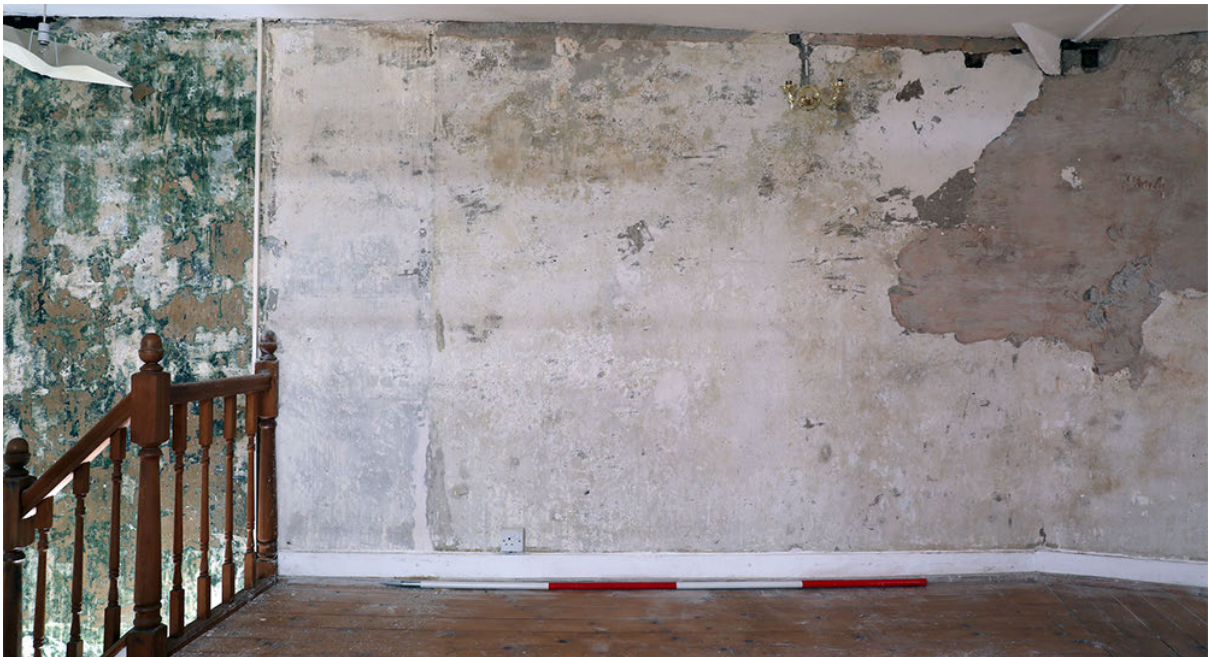
Wall E

- The upper floor of no. 60right was added c.1827, and has been significantly altered since, including the replastering of many of the walls. Evidence of historic decorative schemes survives only on part of Wall E, above the staircase, in the form of a deep, possibly arsenic, green. This likely relates to an earlier boxing in of the staircase and does not continue across in the room.

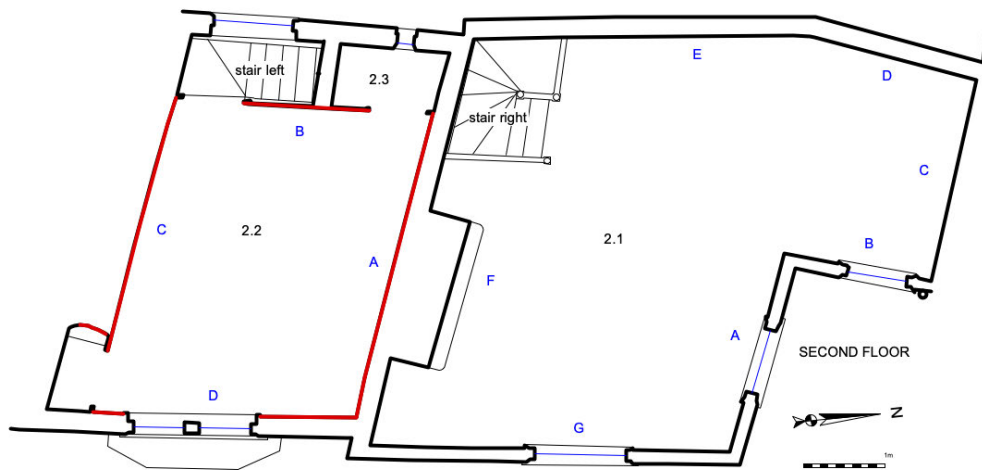
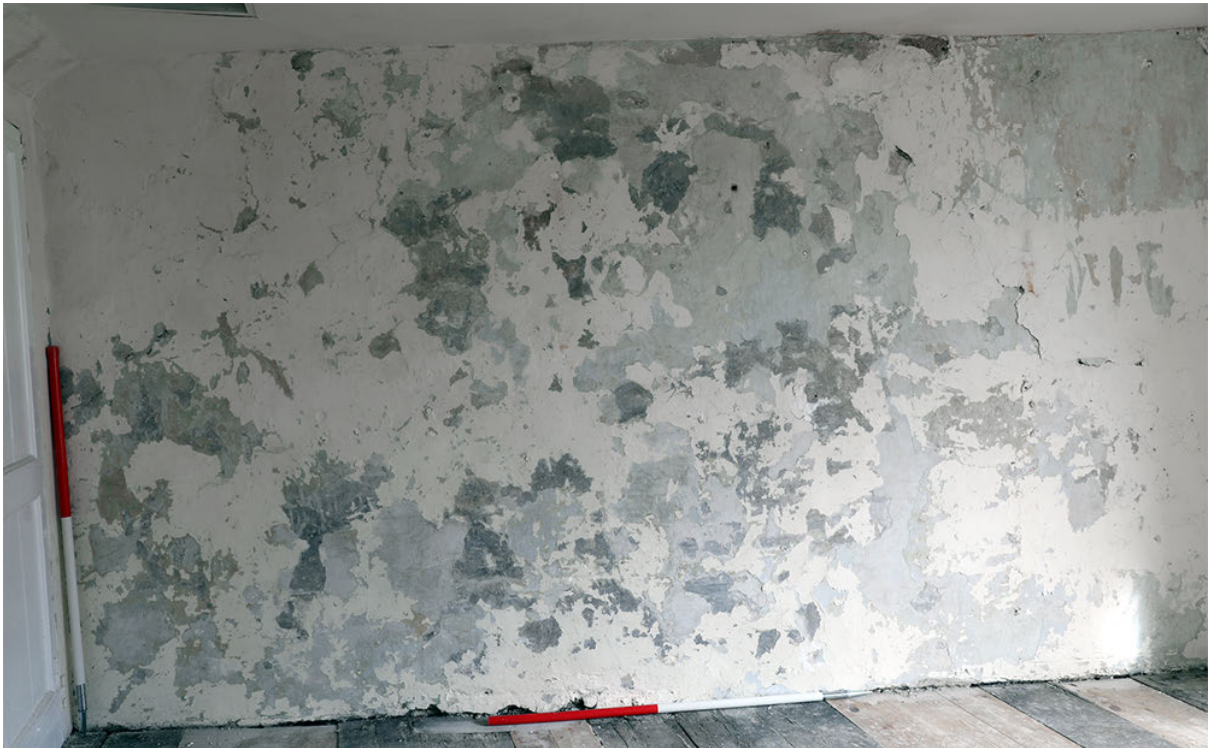
Wall A

- The top floor of no. 60left was likely a bedroom and retains significant evidence for an historic decorative scheme. More than one scheme of pale to medium blue survives on most walls, with a rich marine blue surviving on the woodwork around the doors. On the boarded wall separating the rear staircase, multiple layers of wallpaper survive, including evidence of decorative borders. In the small cupboard beside the chimney breast, a fragment of richly patterned floral wallpaper survives.

- Specialist wallpaper research might be carried out, however given the fragmentary survival of these, the benefit may be limited. The multiple layers of wallpaper in room 2.2 likely all date from the very late C19th and early C20th.
